Milestone Inspection – Phase 1

Cordova Greens V COA

8799 Bardmoor Blvd. Largo, FL 33777

November 15, 2023

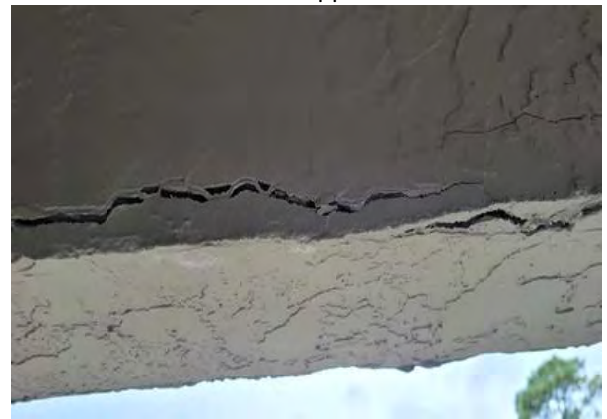
37 Unit 103 Cracked Support

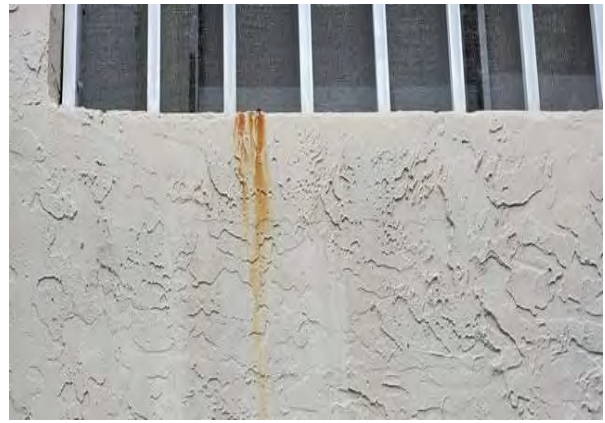
41 Unit 202 Rust at Balcony

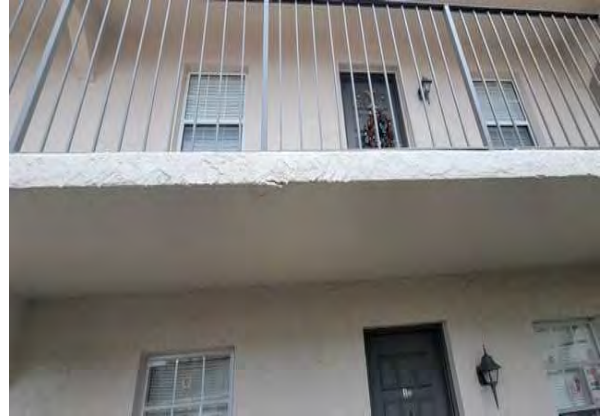
43 Unit 202 Rust at Balcony

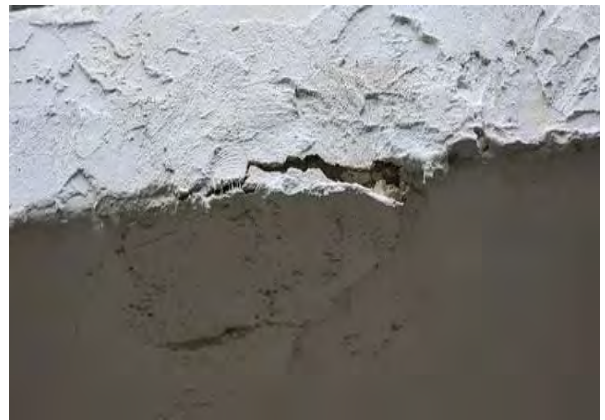
45 Cracked Walk Above Unit 102

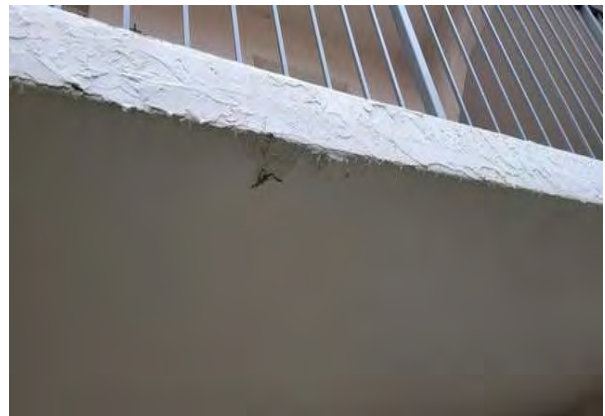
47 Cracked Walk Above Unit 102

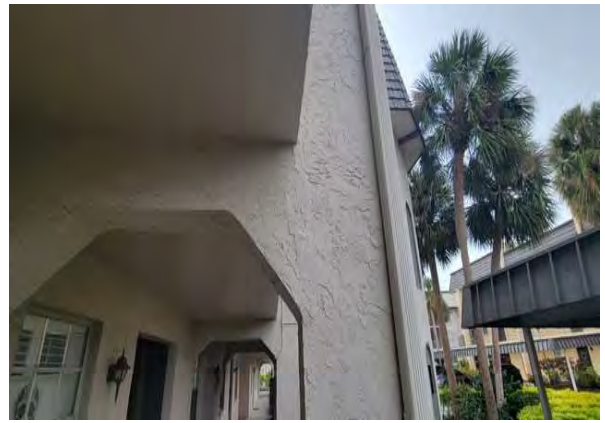
49 Cracked Walk Above Unit 102

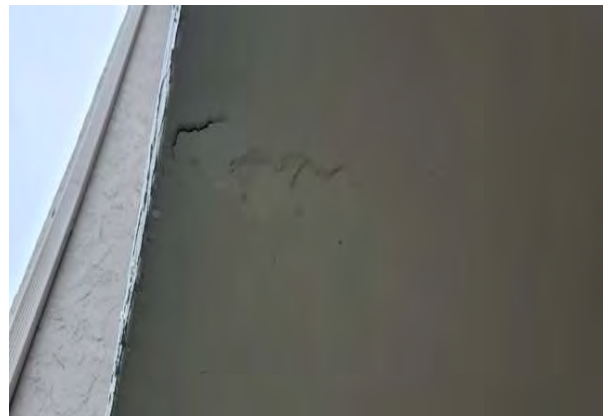
55 Cracked Walk Near Unit 106

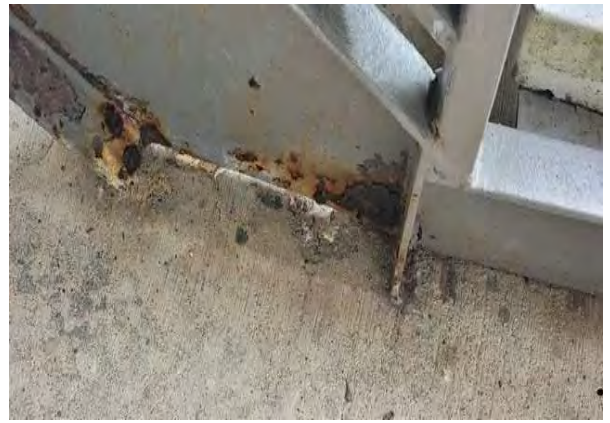
57 Rusted Stringer Right Staircase 1st Floor

For the stairs, we recommend that the stairs have a Phase 2 destructive testing performed to determine if the noted areas are structurally compromised or not. When the breezeways/walkways are sealed, we recommend that the stairs are included to help prevent future structural issues caused by water infiltration as part of a preventative maintenance plan.

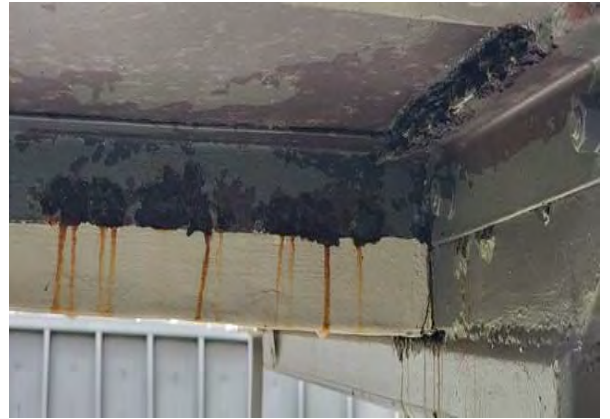
59 Rusted Right Staircase 1st Floor

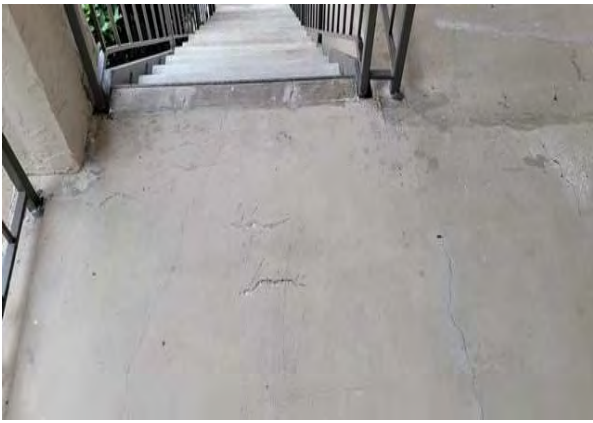
64 Rusted Right Staircase 1st Floor

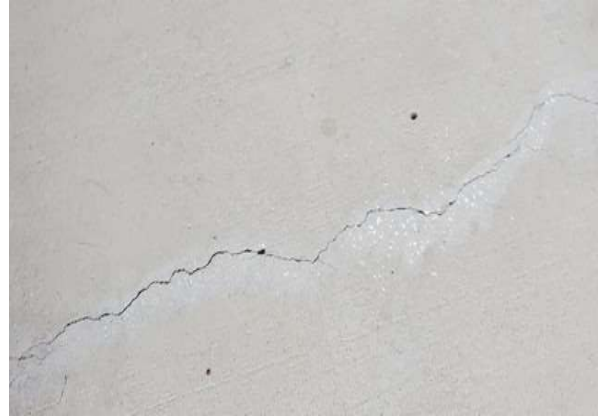
67 2nd Floor Right Staircase Cracked Walk

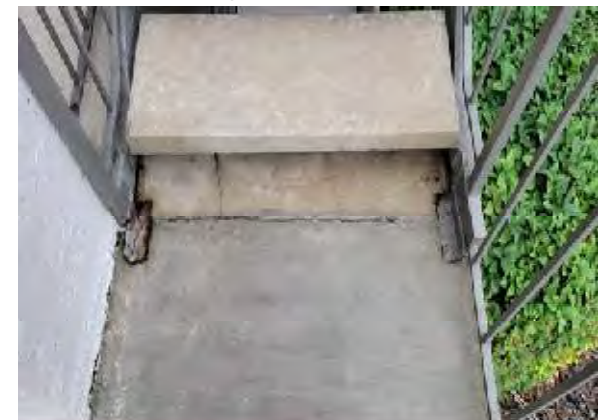
69 2nd Floor Right Staircase Cracked Walk

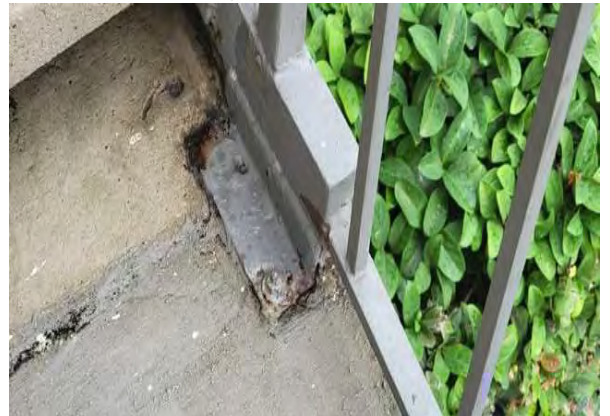
71 2nd Floor Right Staircase Rusted Bracket

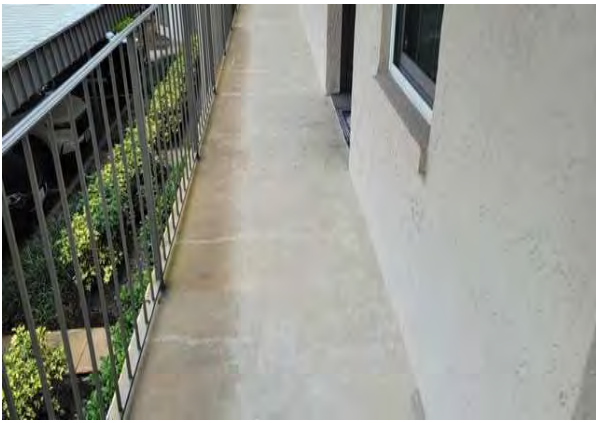
72 2nd Floor Right Staircase Rusted Bracket

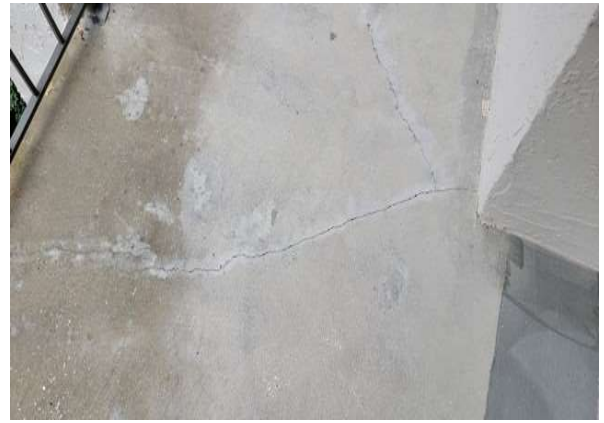
73 Cracked Walk Multiple Areas 2nd Floor

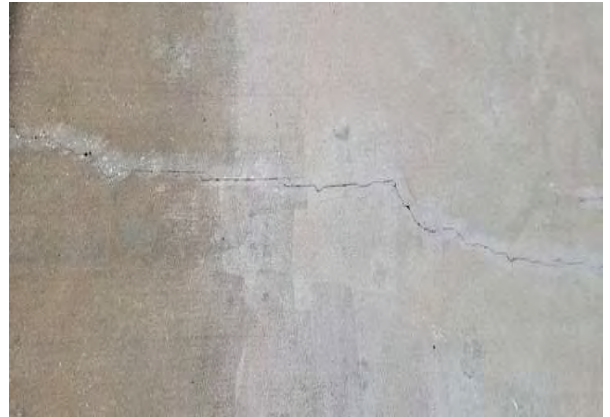
75 Cracked Walk Multiple Areas 2nd Floor

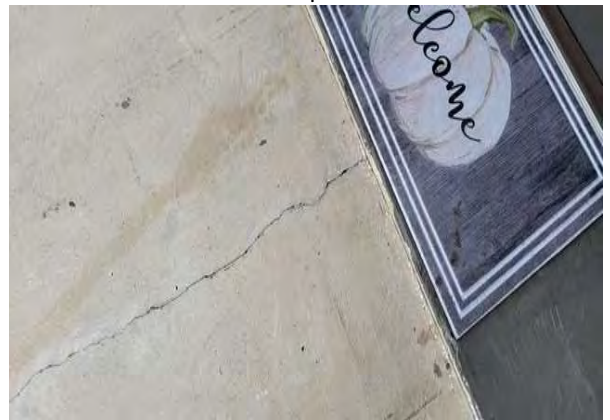
77 Cracked Walk Multiple Areas 2nd Floor

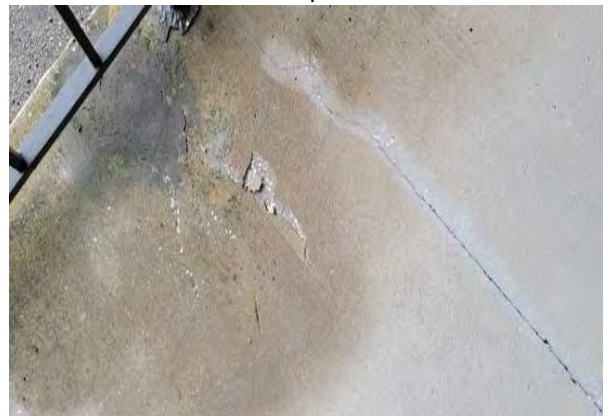
79 Spalled Concrete Near Unit 204

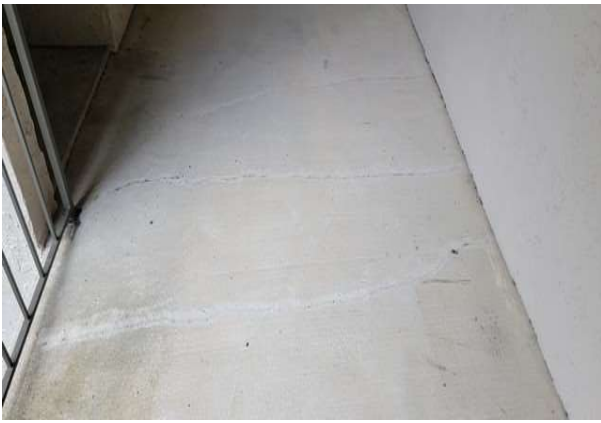
80 Spalled Concrete Near Unit 204

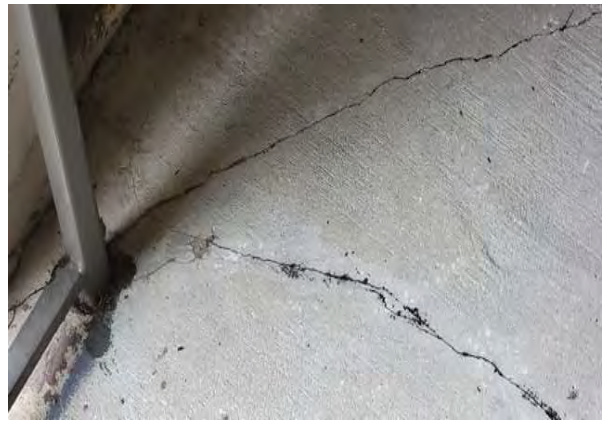
81 Cracked Walk Near 2nd Floor Elevator Door

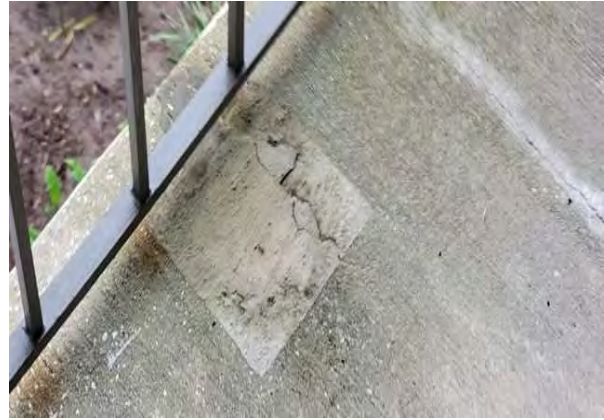
85 Failing repair Near Unit 202

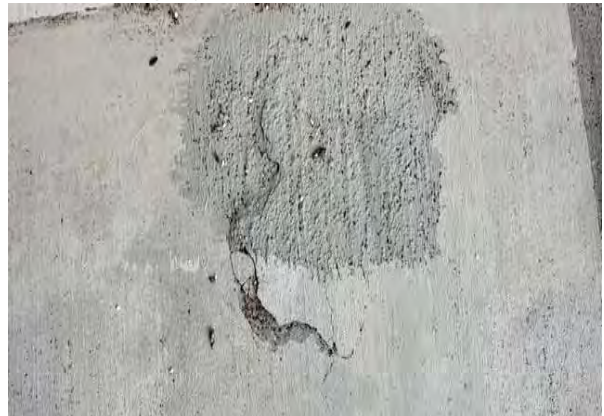
87 Failing Repairs to Walk 3rd Floor Near Left Stairs

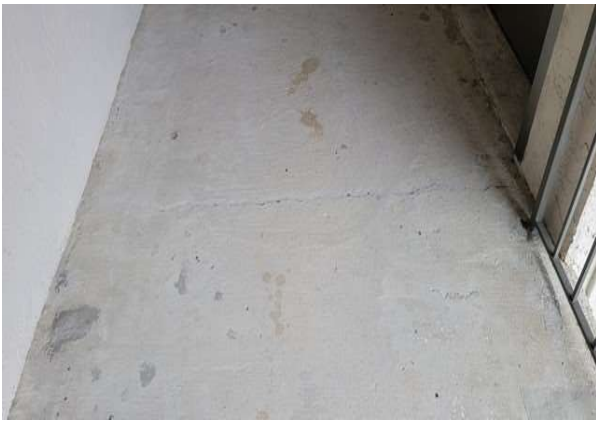
96 Cracked Walk Near Unit 301

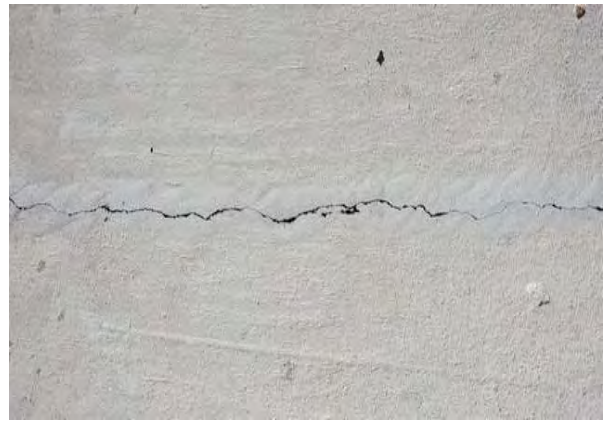
97 Cracked Walk Near 3rd Floor Elevator

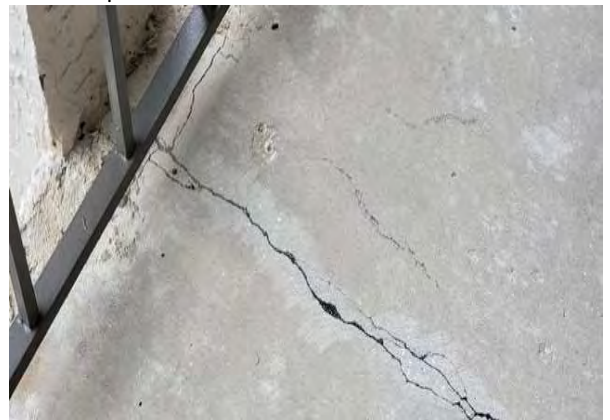
101 Cracked Walk Near Unit 305

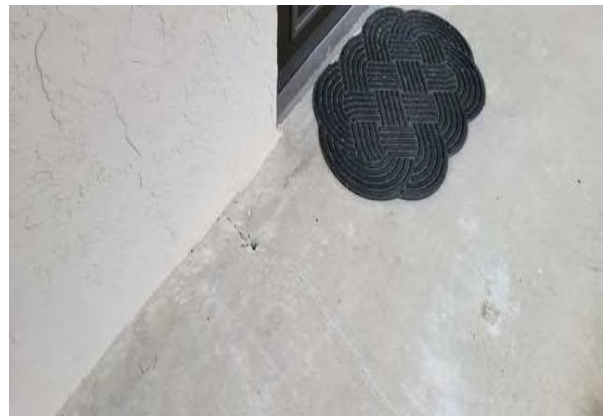
103 Cracked Walk Near Unit 305

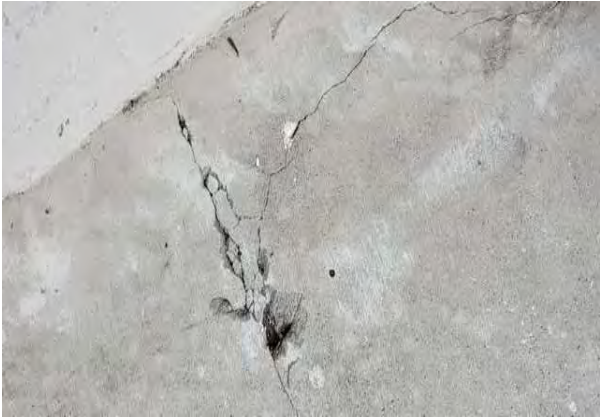
104 Spalled Concrete Near Unit 305

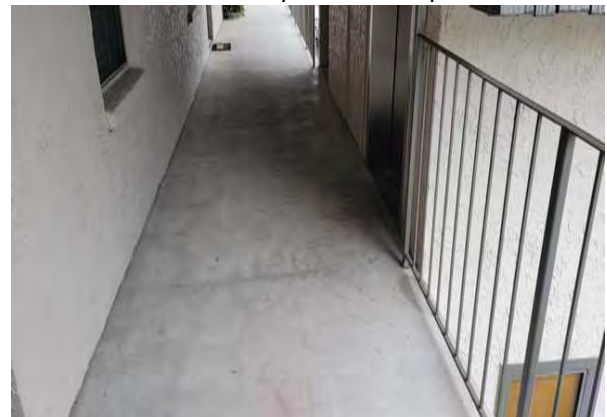
36 Cracked Walkway Near 303

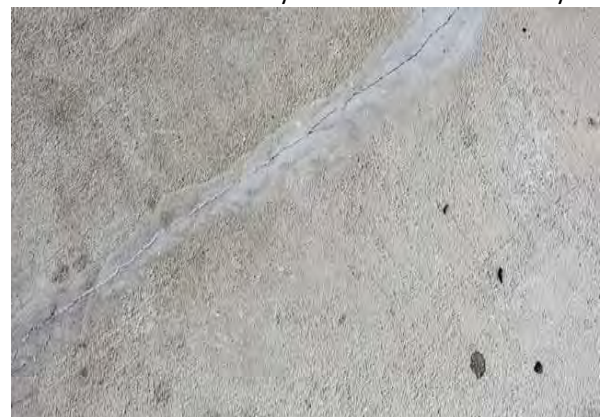
38 Cracked Walkway 3rd Floor Elevator Lobby

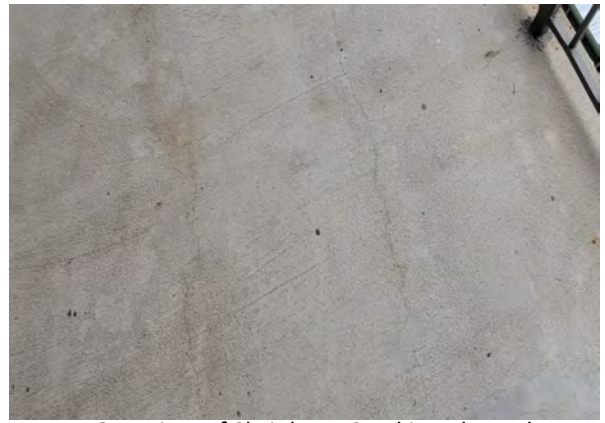
40 Overview of Shrinkage Cracking Throughout Building

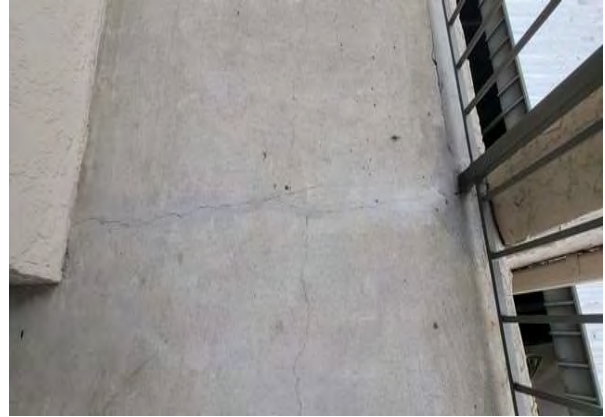
42 Crack in Walkway Near Unit 304

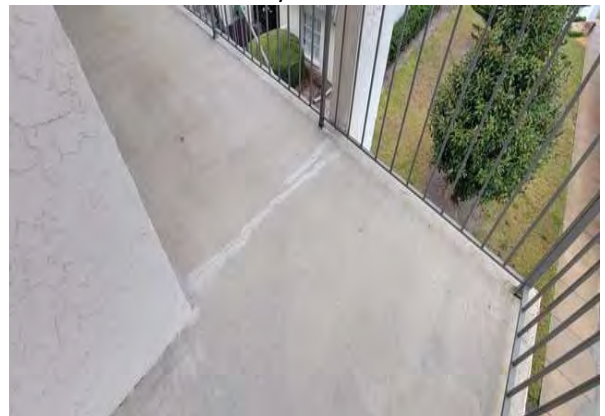
46 Crack in Walkway Near Unit 304

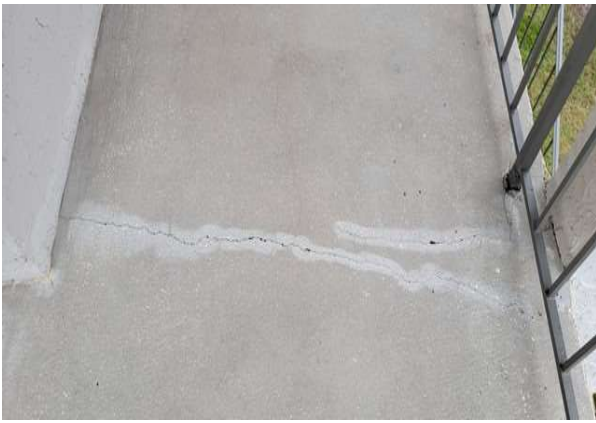
47 Crack in Walkway Near Unit 306

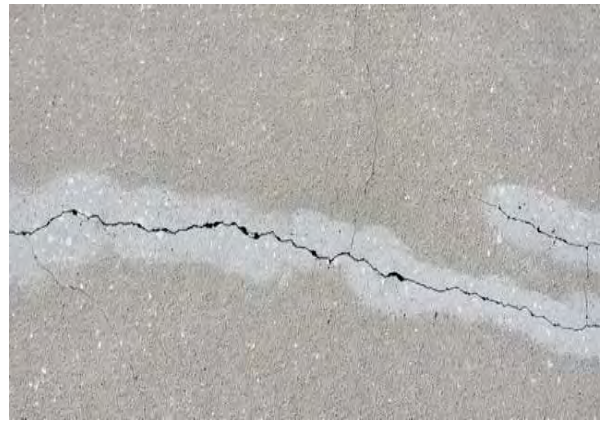
48 Crack in Walkway Near Unit 306

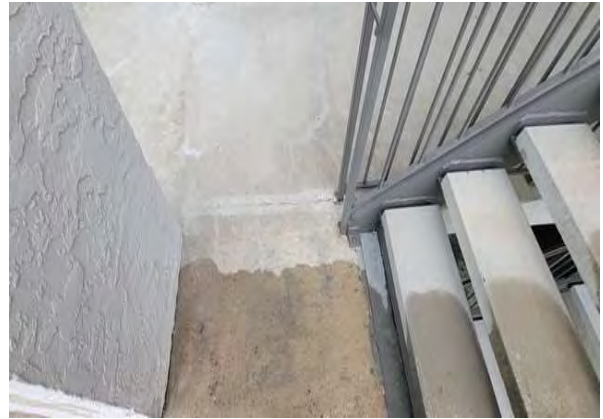
50 Crack in Walkway Near Unit 306

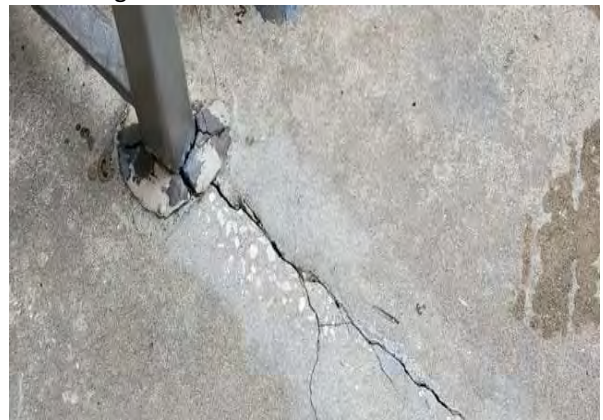
52 Crack in Walkway Base of Stairs 2nd Floor
Right Side

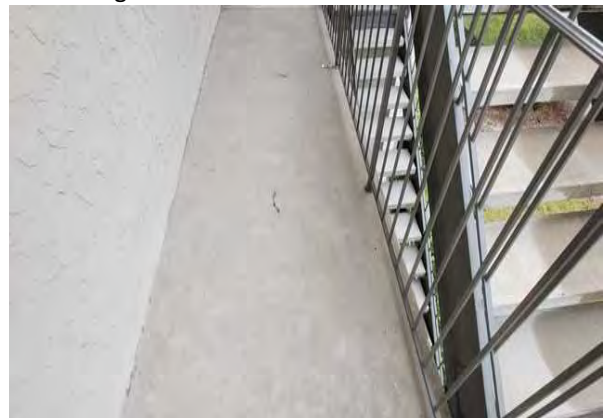
54 Crack in Walkway Base of Stairs 2nd Floor
Right Side

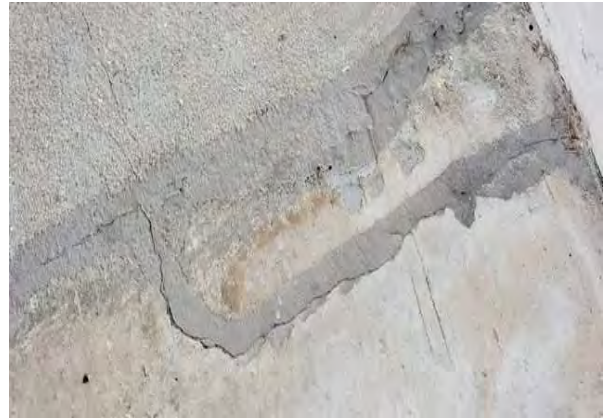
58 Crack in Walkway 2nd Floor Stairs Down
Right Side

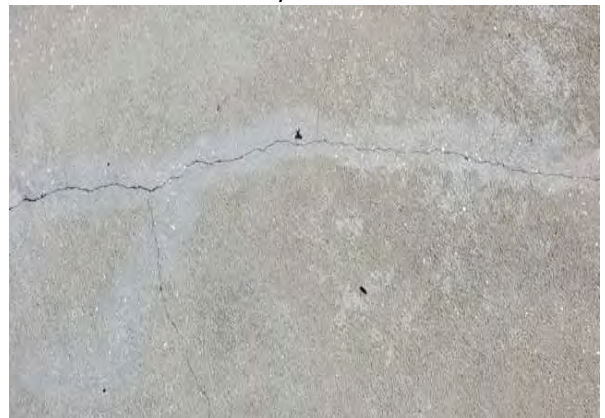
62 Crack in Walkway Near Unit 206

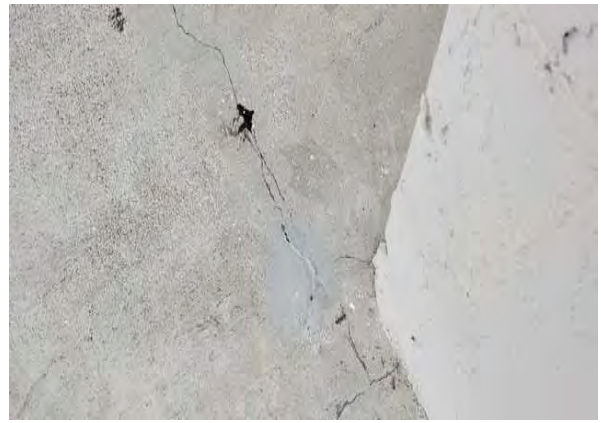
72 Crack in Walkway Near Unit 204

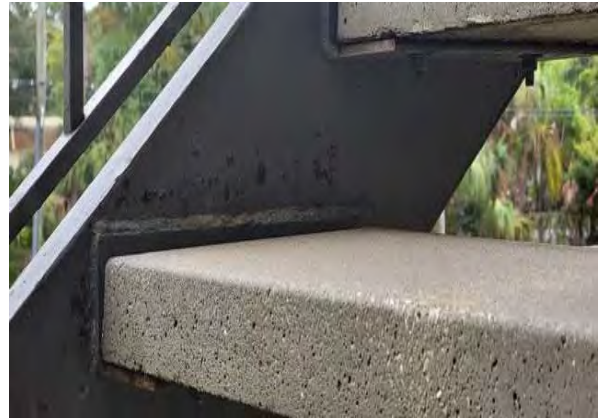
82 Rusted Stringer 2nd Floor to 3rd Floor at Left Stairs

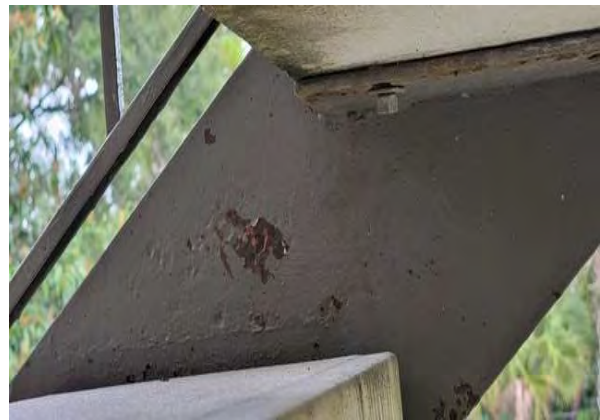
84 Rusted Stringer 2nd Floor to 3rd Floor at Left Stairs

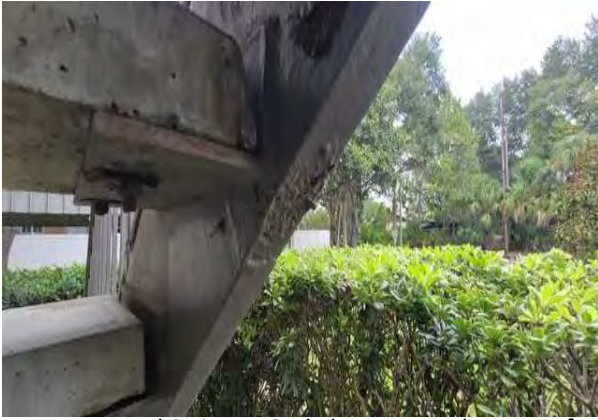
87 Rusted Stringer 2nd Floor to 1st Floor at Left Stairs
