Reserve Study

Cordova Greens V COA

This Report contains Structural Reserve Study for the Property
with Address of:

November 15, 2023

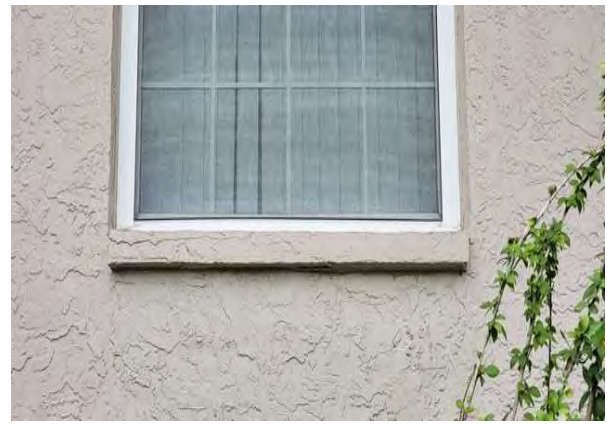
33 Unit 204 Cracked Sill

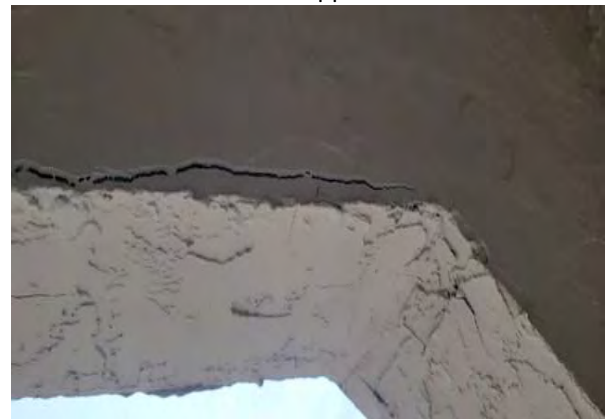
39 Unit 103 Cracked Support

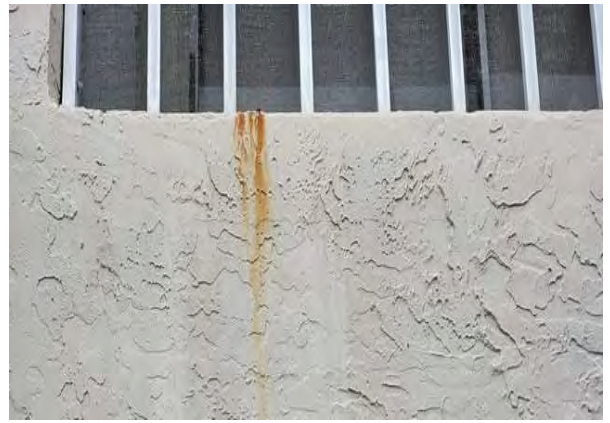
41 Unit 202 Rust at Balcony

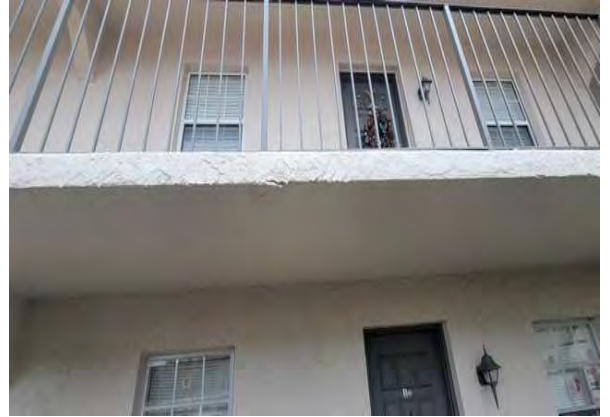
43 Unit 202 Rust at Balcony

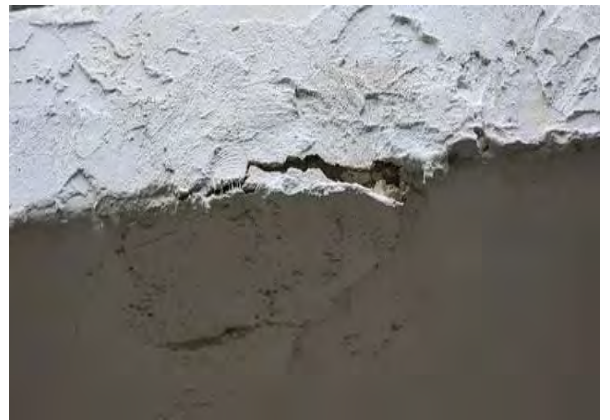
45 Cracked Walk Above Unit 102

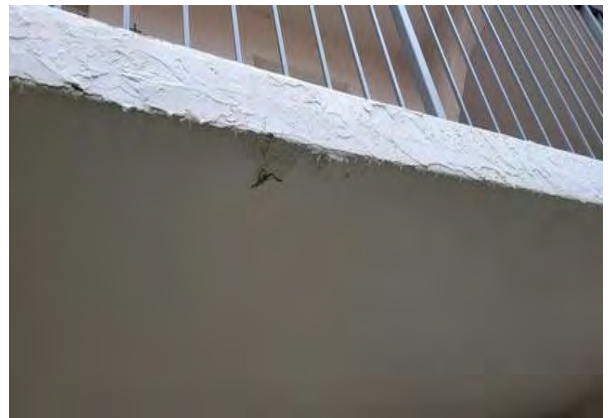
47 Cracked Walk Above Unit 102

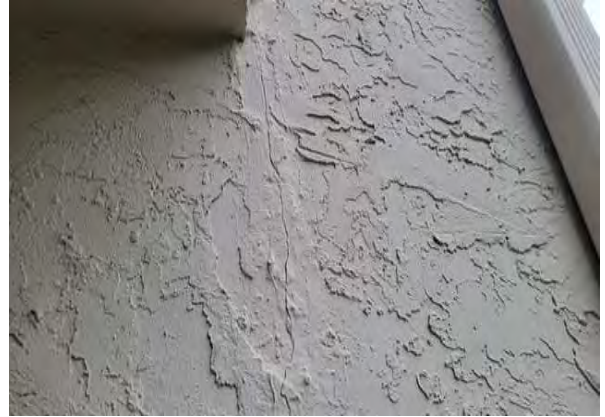
51 Crack in Wall Near Unit 103

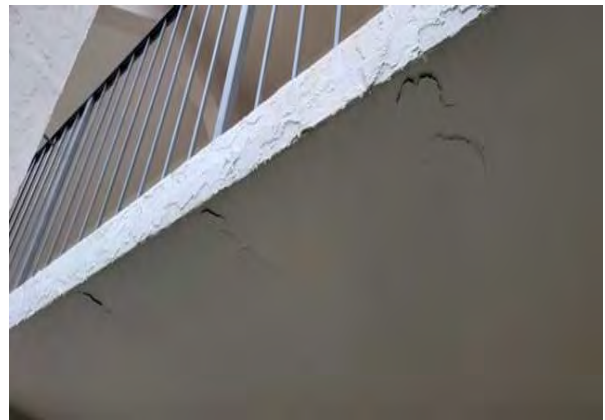
53 Cracked Walk Near Unit 106

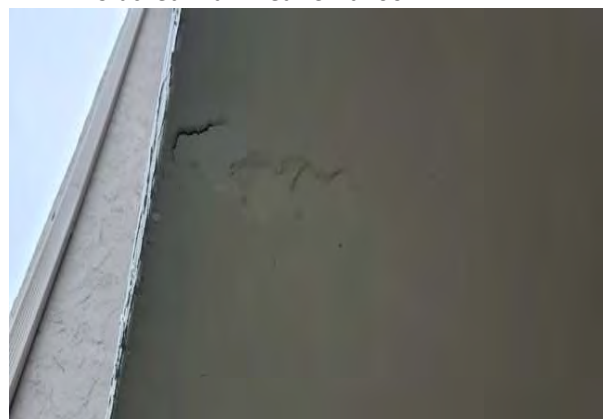
55 Cracked Walk Near Unit 106

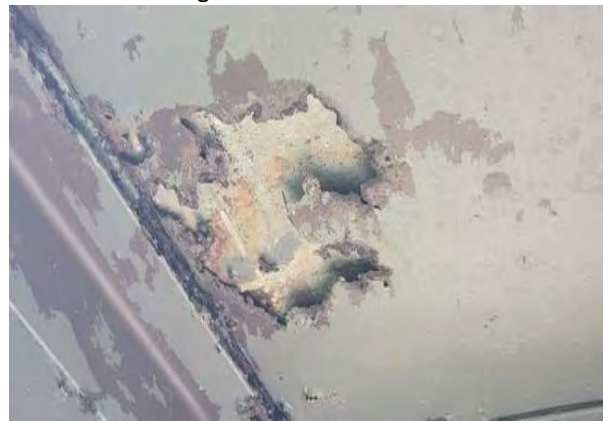
61 Rusted Right Staircase 1st Floor

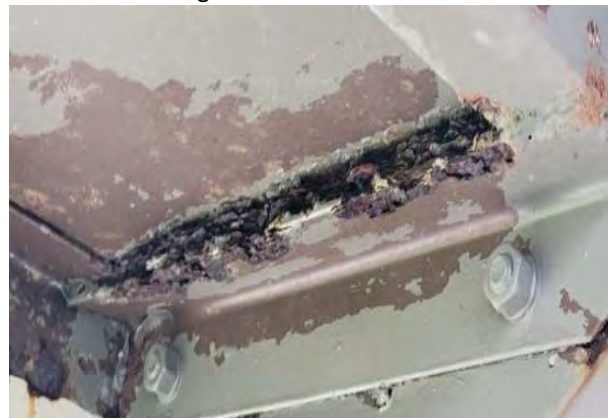
63 Rusted Right Staircase 1st Floor

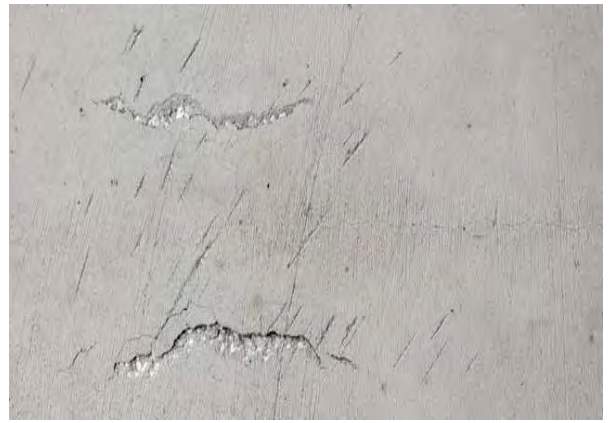
65 2nd Floor Right Staircase Spalled Concrete

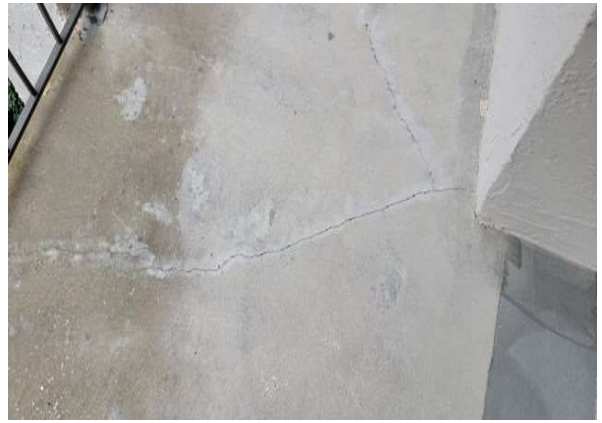
73 Cracked Walk Multiple Areas 2nd Floor

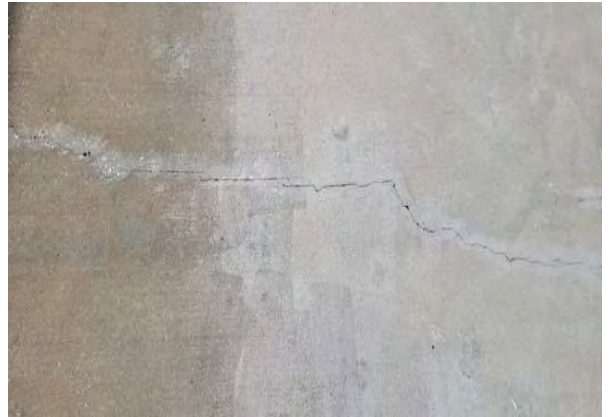
75 Cracked Walk Multiple Areas 2nd Floor

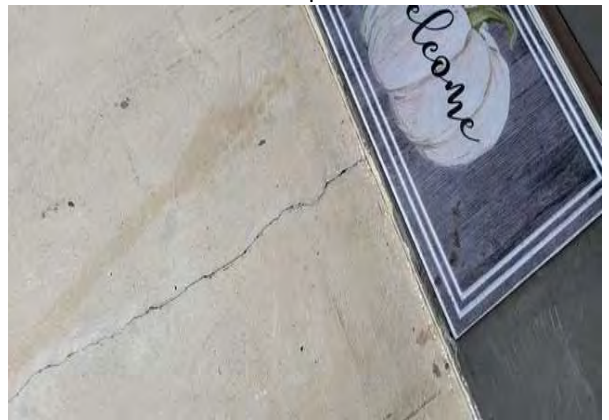
77 Cracked Walk Multiple Areas 2nd Floor

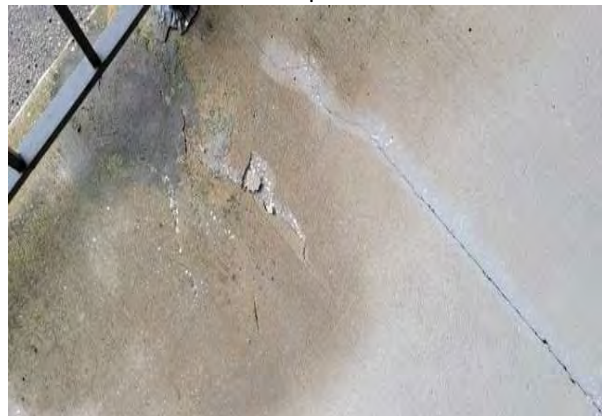
79 Spalled Concrete Near Unit 204

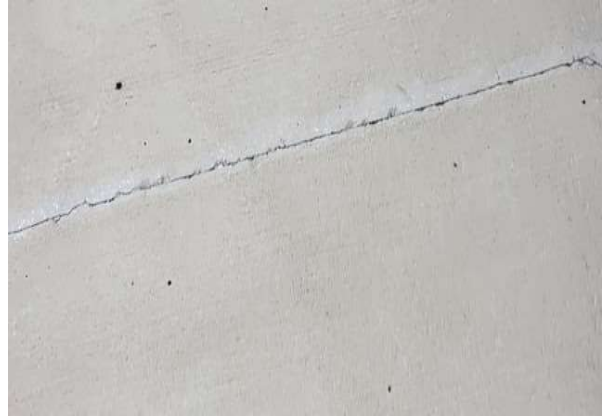
83 Cracked Walk Near Unit 203

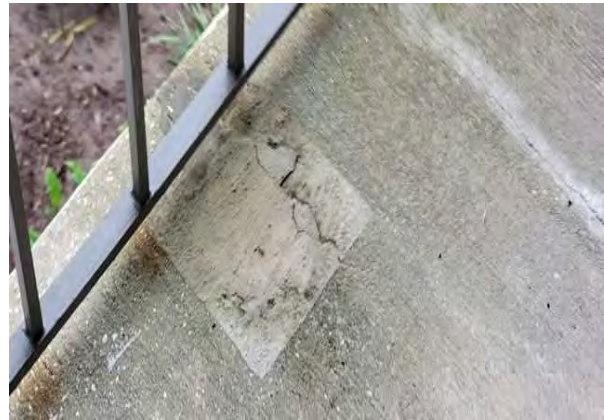
85 Failing repair Near Unit 202

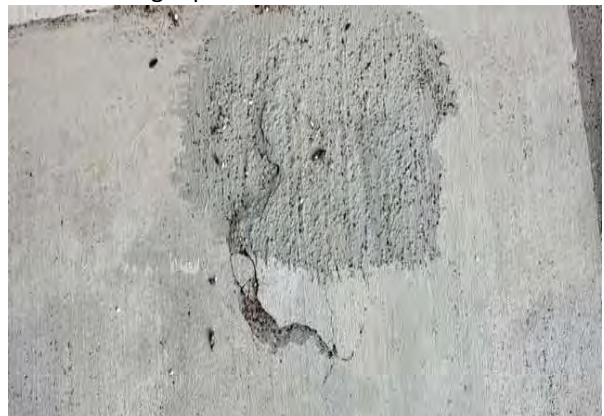
87 Failing Repairs to Walk 3rd Floor Near Left Stairs

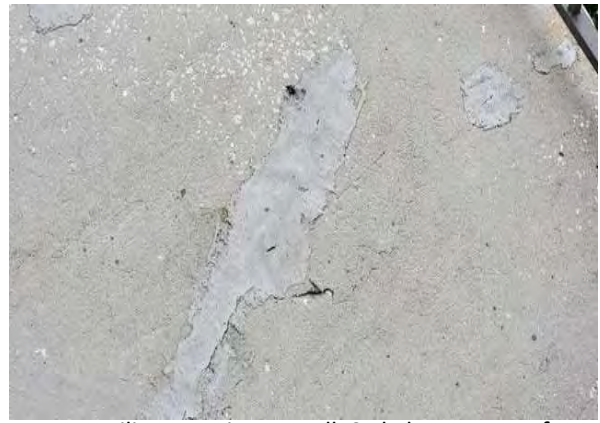
89 Failing Repairs to Walk 3rd Floor Near Left Stairs

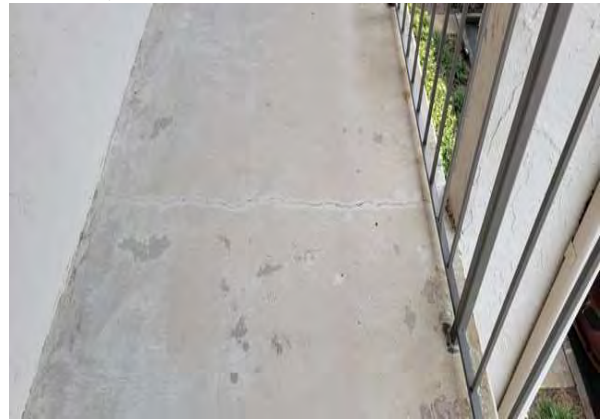
93 Spalled Concrete Near Unit 301

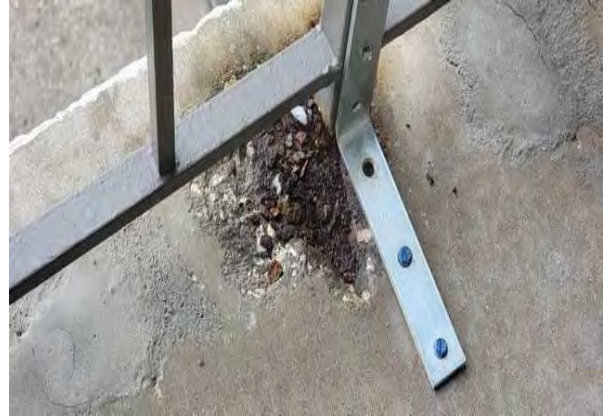
99 Spalled Concrete Ner Unit 304

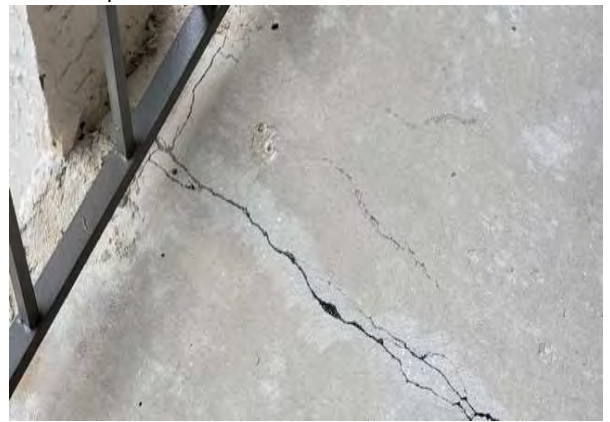
101 Cracked Walk Near Unit 305

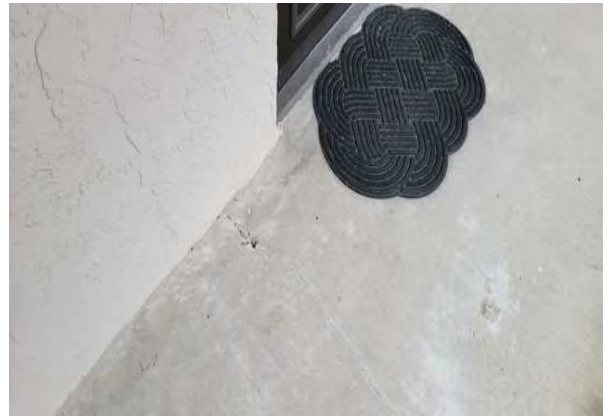
103 Cracked Walk Near Unit 305

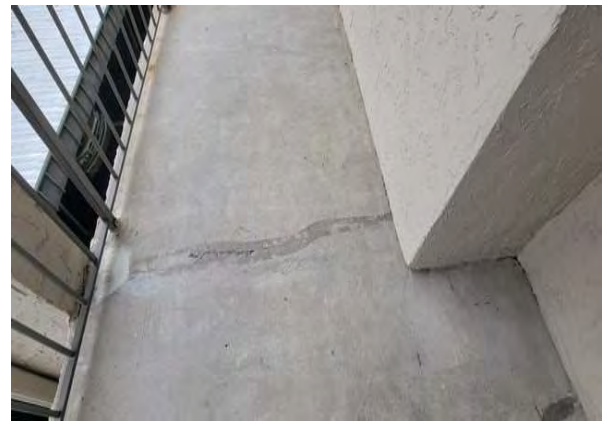
32 Cracked Walkway Near 303

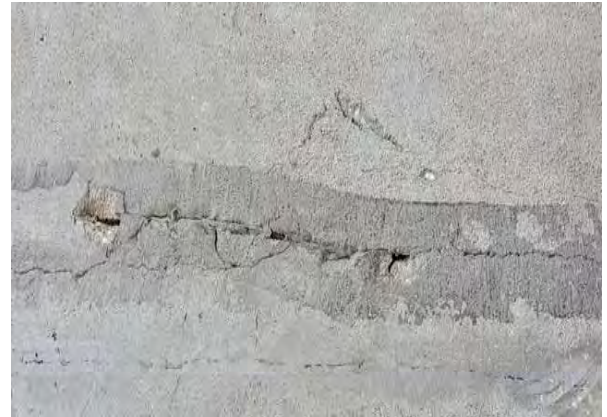
34 Cracked Walkway Near 303

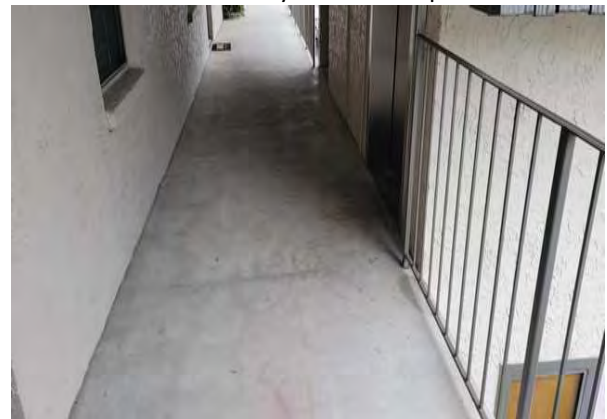
36 Cracked Walkway Near 303

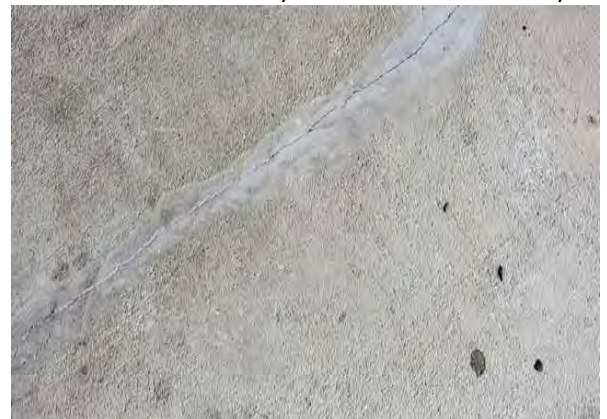
38 Cracked Walkway 3rd Floor Elevator Lobby

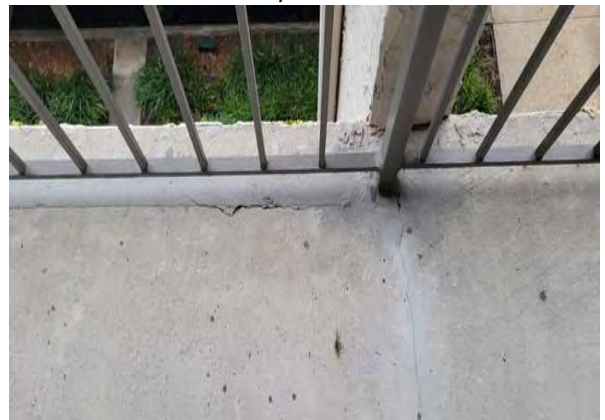
44 Crack in Walkway Near Unit 304

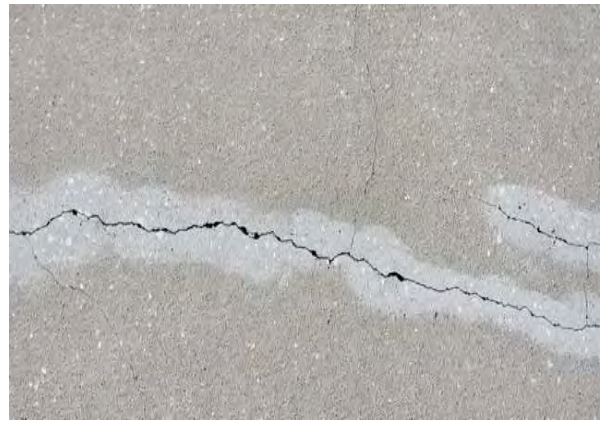
48 Crack in Walkway Near Unit 306

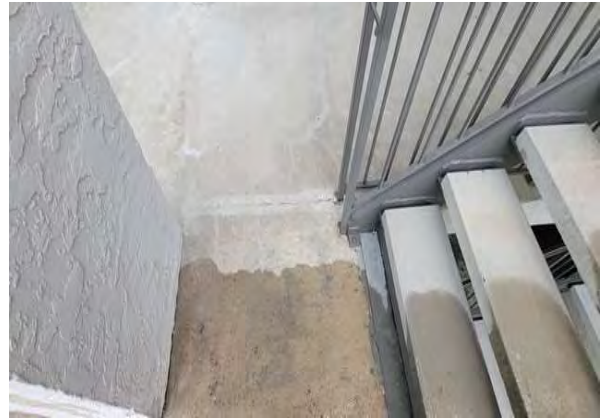
50 Crack in Walkway Near Unit 306

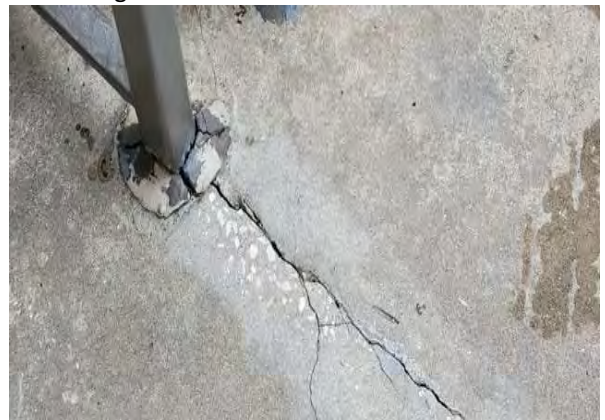
52 Crack in Walkway Base of Stairs 2nd Floor
Right Side

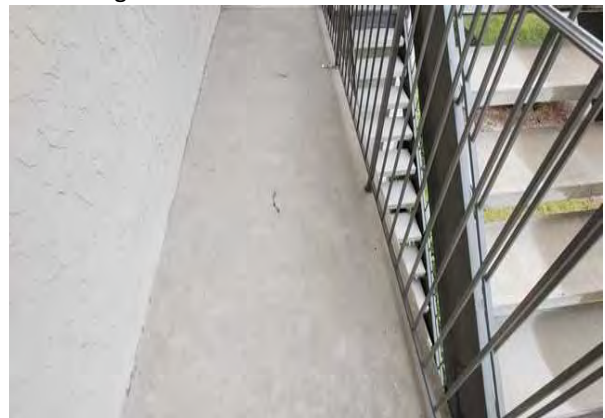
54 Crack in Walkway Base of Stairs 2nd Floor
Right Side

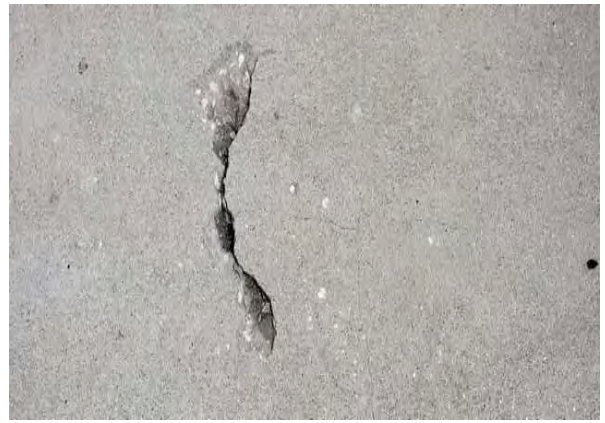
56 Spalled Concrete 2nd Floor Near Right Stairs

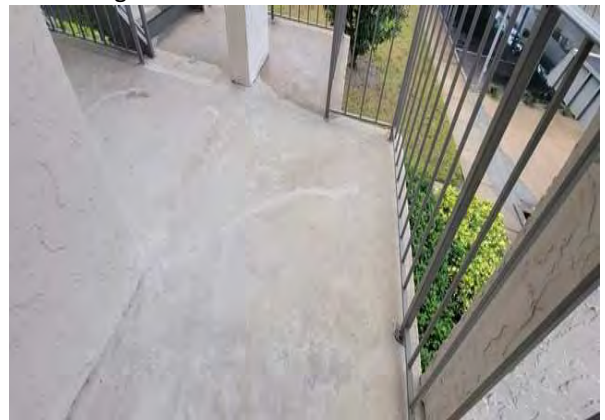
60 Crack in Walkway 2nd Floor Stairs Down
Right Side

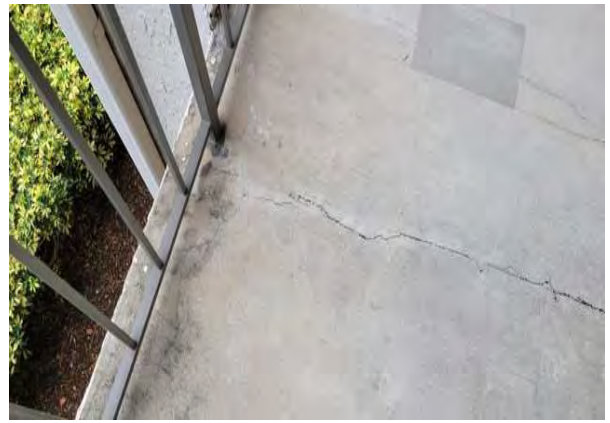
64 Crack in Walkway Near Unit 205

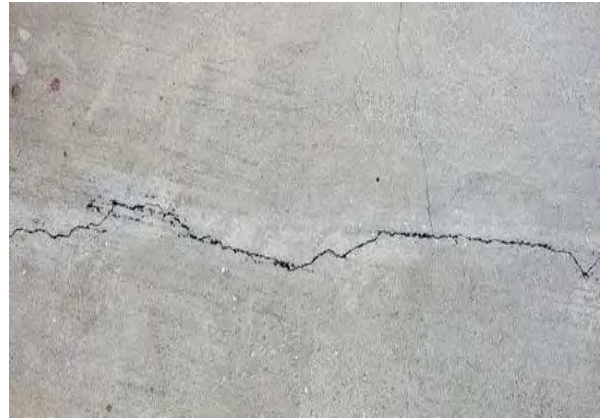
66 Crack in Walkway Near Unit 205

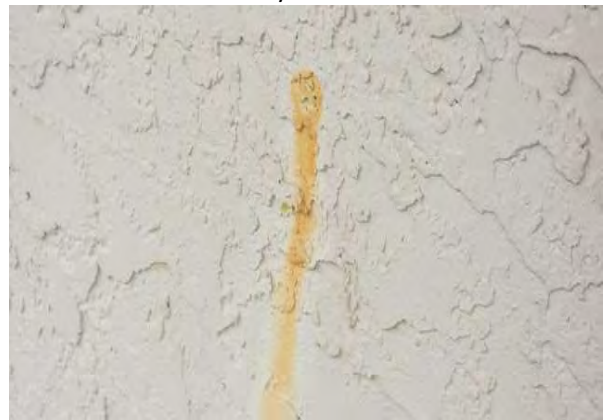
68 Rust at Wall Near Unit 206

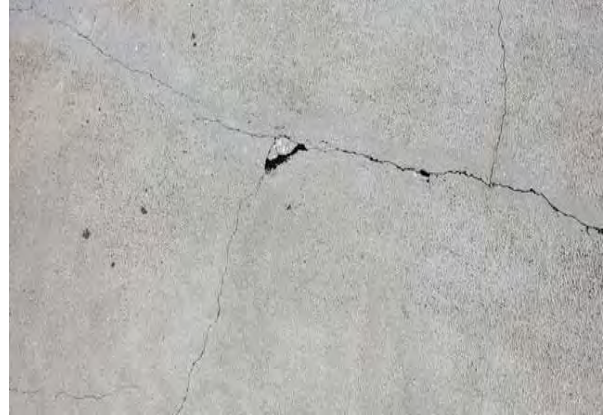
70 Crack in Walkway Near Unit 204

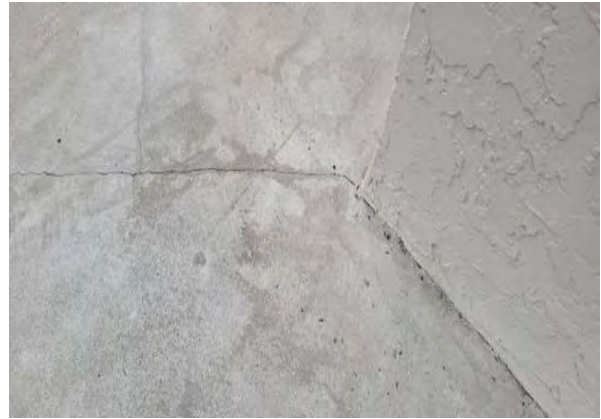
74 Crack in Walkway 2nd Floor Front Left Corner

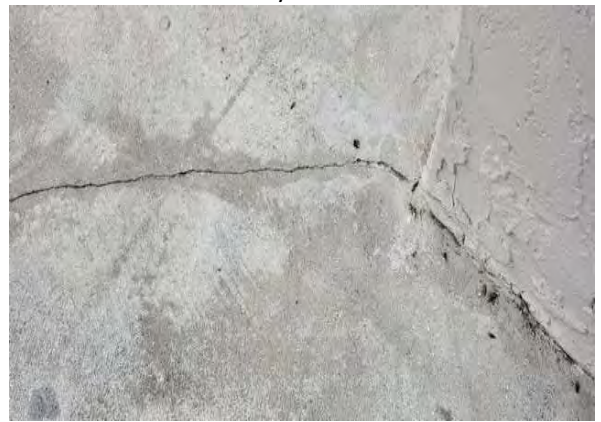
76 Crack in Walkway 2nd Floor Front Left Corner

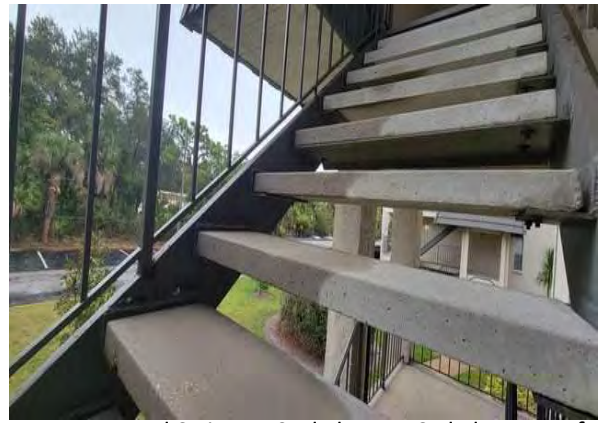
80 2nd Floor Rusted Handrail Left Stairs

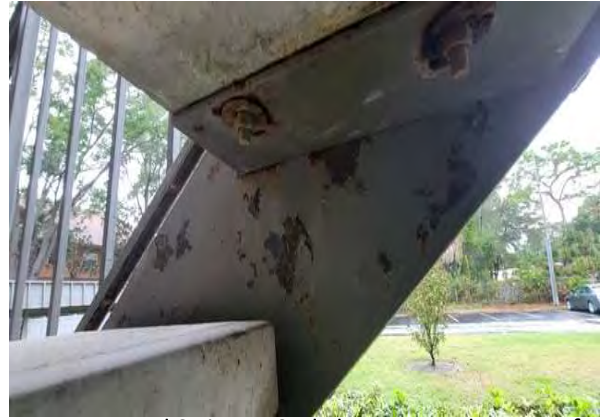
88 Rusted Stringer 2nd Floor to 1st Floor at Left Stairs
