Milestone Inspection – Phase 1

Cordova Greens V COA

8799 Bardmoor Blvd. Largo, FL 33777

November 15, 2023

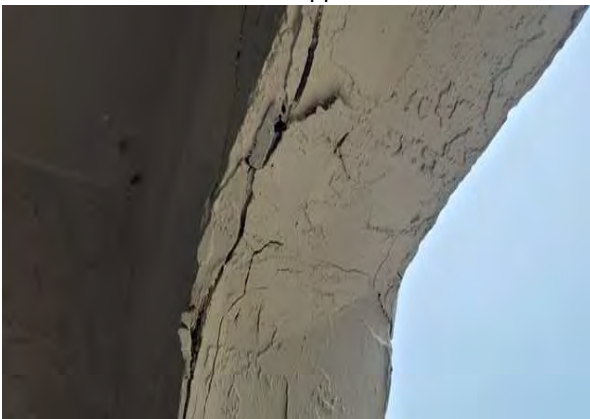
39 Unit 103 Cracked Support

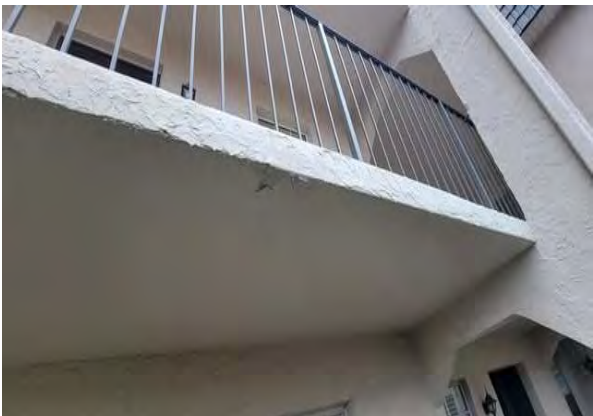
47 Cracked Walk Above Unit 102

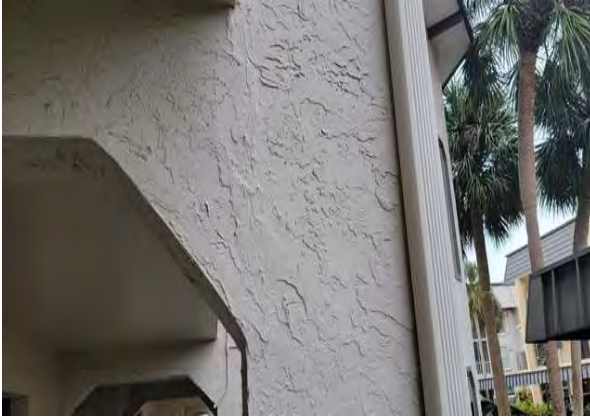
51 Crack in Wall Near Unit 103

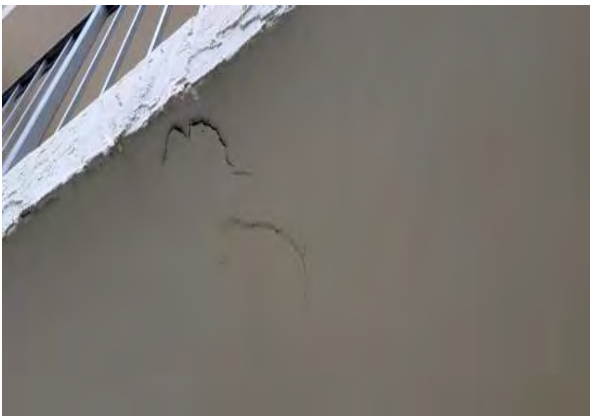
55 Cracked Walk Near Unit 106

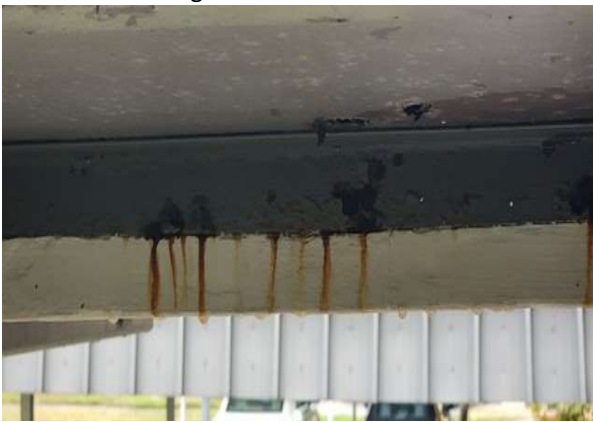
61 Rusted Right Staircase 1st Floor

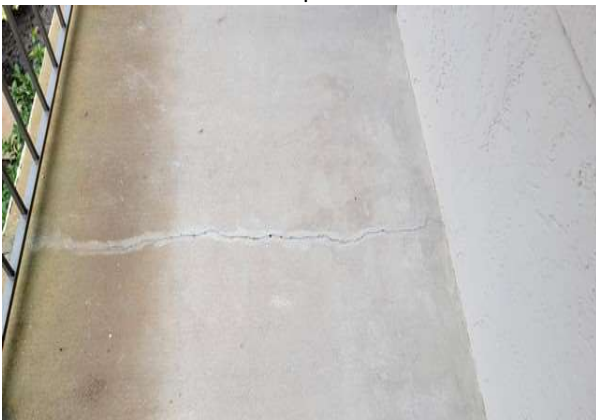
77 Cracked Walk Multiple Areas 2nd Floor

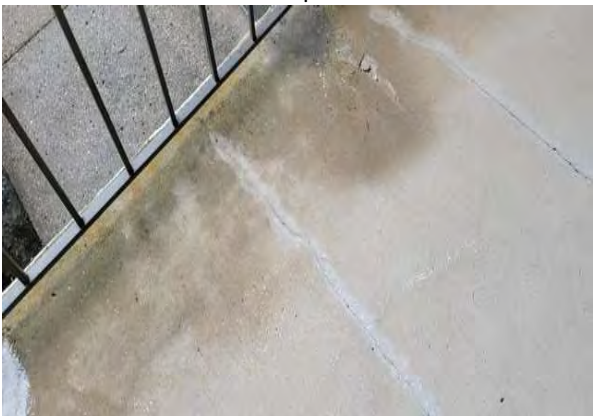
79 Spalled Concrete Near Unit 204

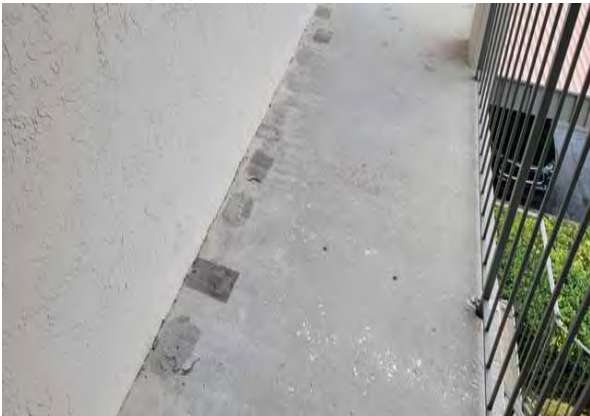
87 Failing Repairs to Walk 3rd Floor Near Left Stairs

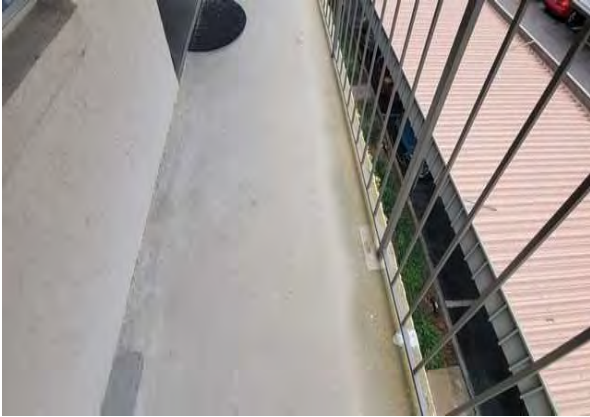
91 Spalled Concrete Near Unit 301

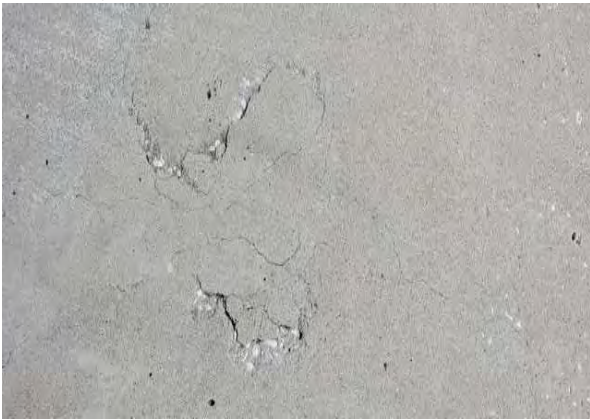
93 Spalled Concrete Near Unit 301

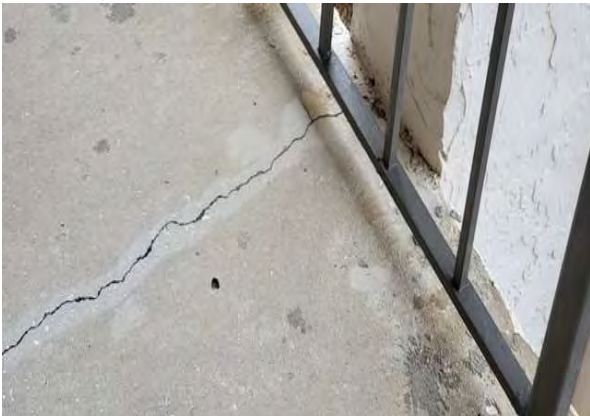
95 Cracked Walk Near Unit 301

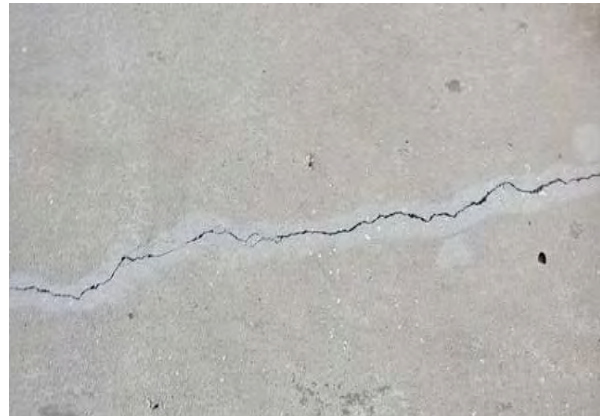
96 Cracked Walk Near Unit 301

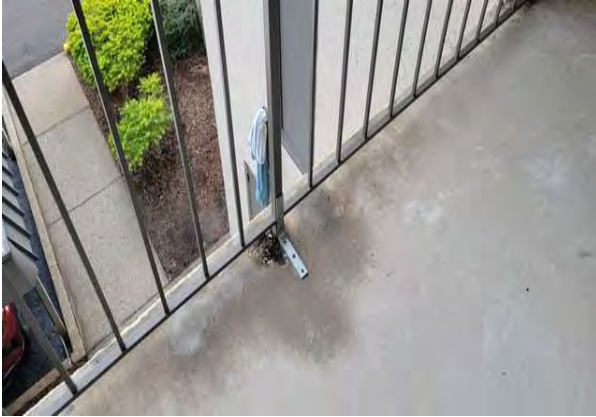
99 Spalled Concrete Ner Unit 304

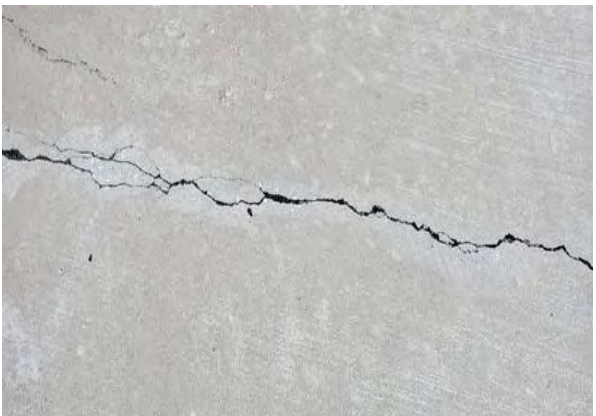
103 Cracked Walk Near Unit 305

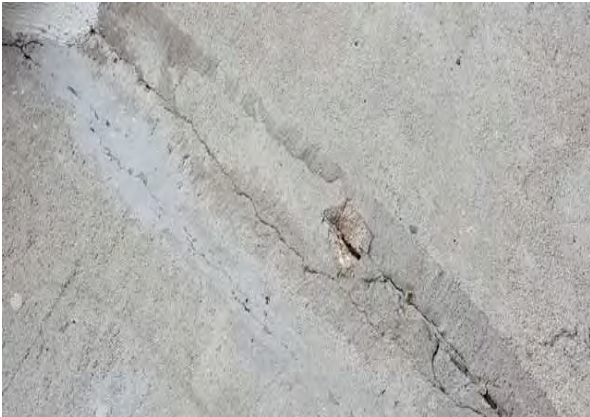
33 Cracked Walkway Near 303

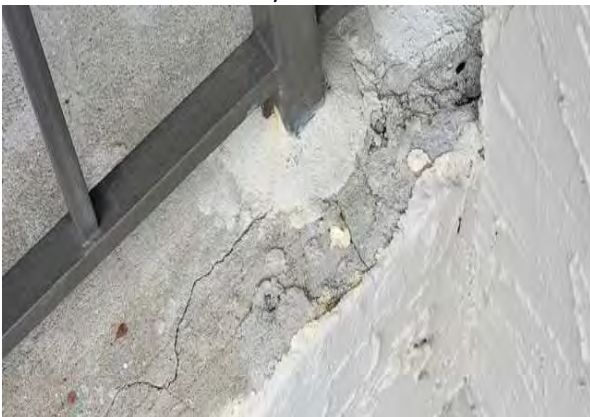
35 Cracked Walkway Near 303 Exposed Rebar

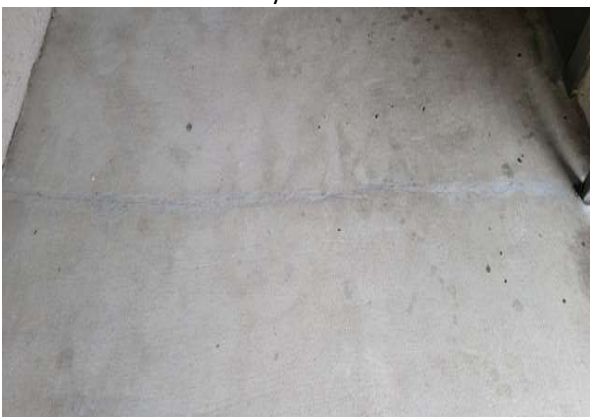
37 Cracked Walkway 3rd Floor Elevator Lobby

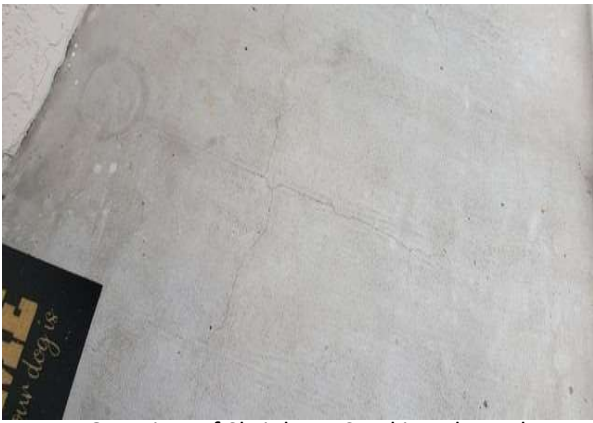
39 Cracked Walkway 3rd Floor Elevator Lobby

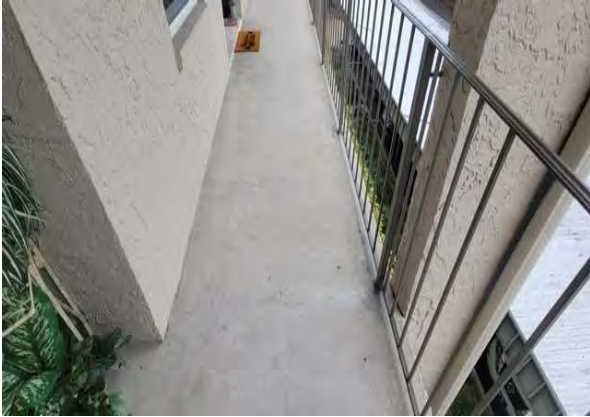
41 Overview of Shrinkage Cracking Throughout Building

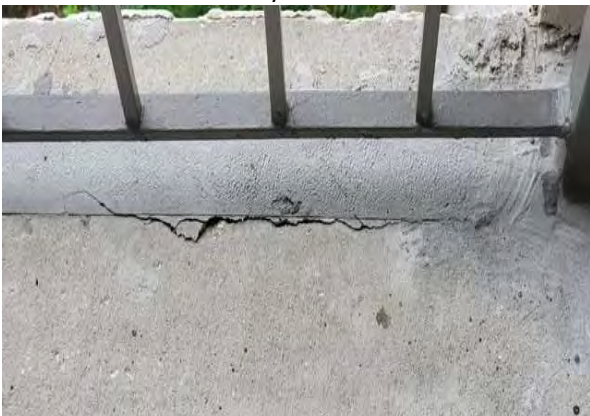
45 Crack in Walkway Near Unit 304

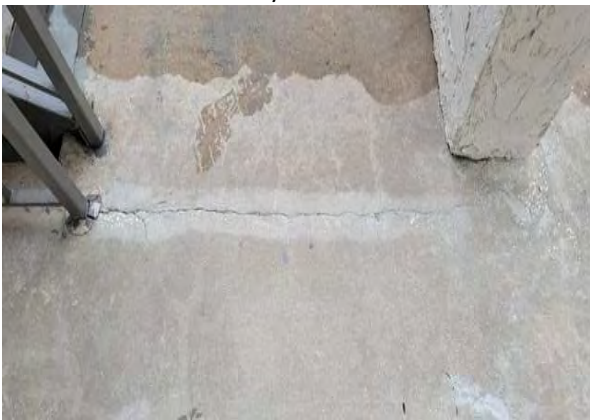
51 Crack in Walkway Base of Stairs 2nd Floor
Right Side

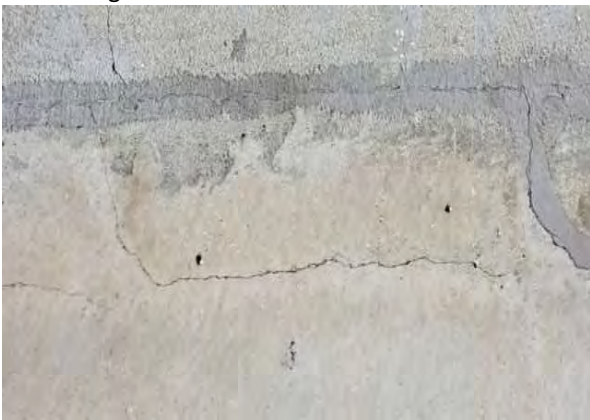
59 Crack in Walkway 2nd Floor Stairs Down
Right Side

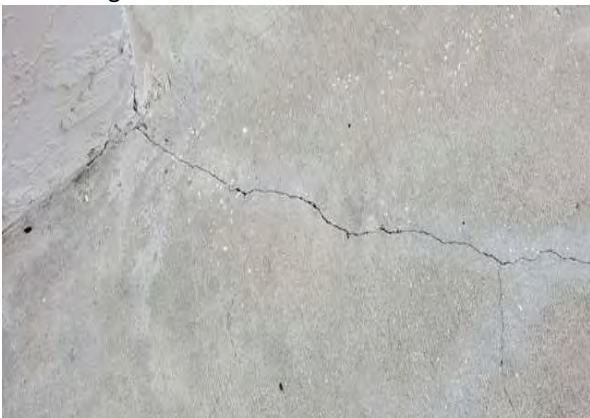
61 Crack in Walkway Near Unit 206

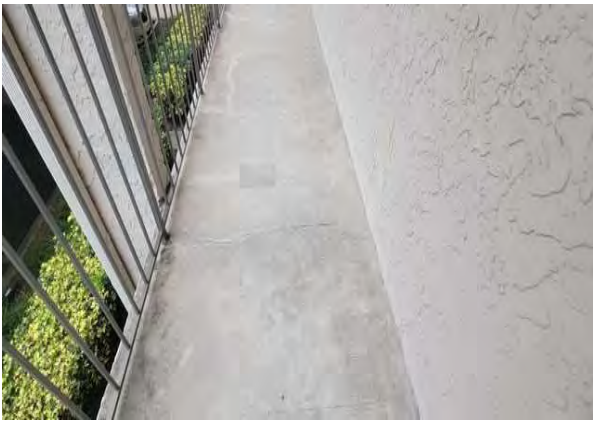
63 Crack in Walkway Near Unit 206

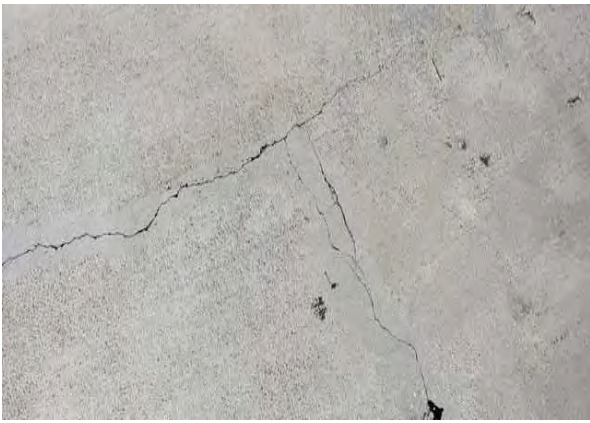
71 Crack in Walkway Near Unit 204

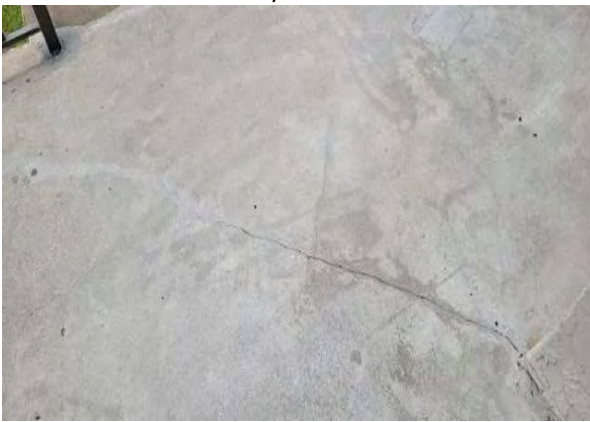
75 Crack in Walkway 2nd Floor Front Left Corner

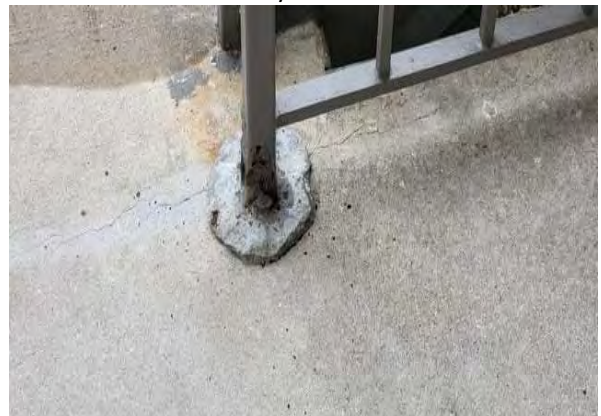
79 2nd Floor Rusted Handrail Left Stairs

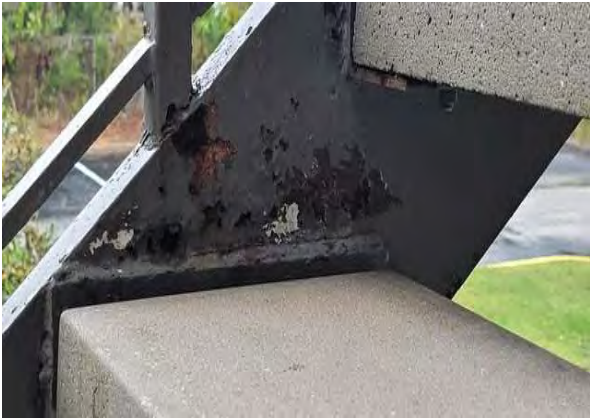
82 Rusted Stringer 2nd Floor to 3rd Floor at Left Stairs

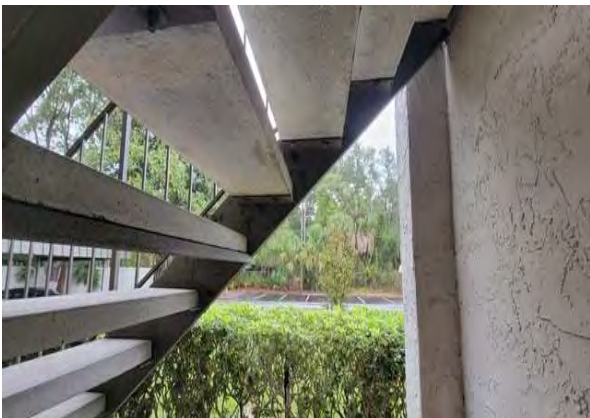
86 Rusted Stringer 2nd Floor to 1st Floor at Left Stairs

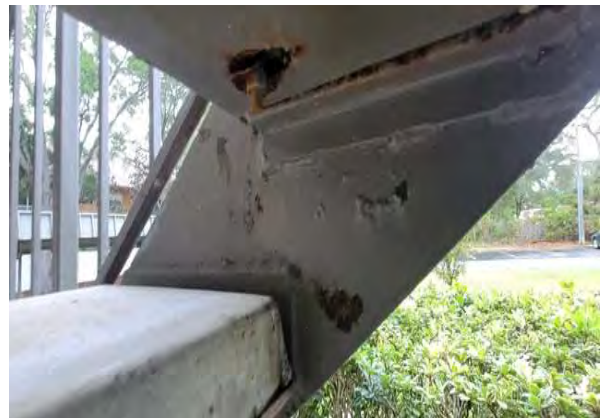
87 Rusted Stringer 2nd Floor to 1st Floor at Left Stairs

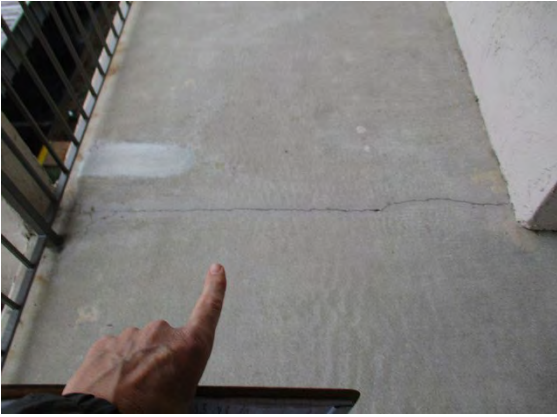
8 3rd Floor Walkway Cracked In Multiple Areas

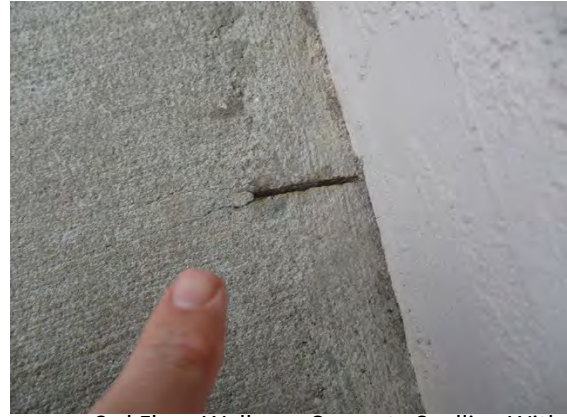
9 3rd Floor Walkway Cracked In Multiple Areas

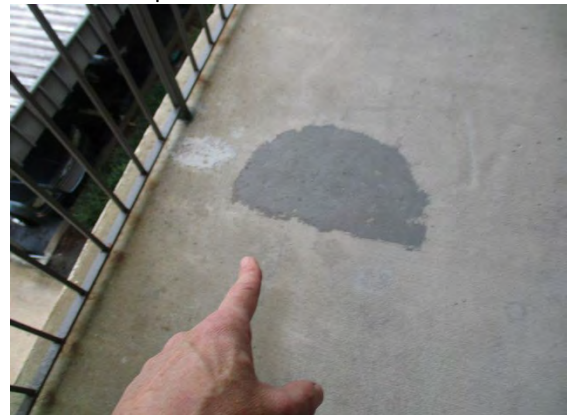
13 3rd Floor Walkway Prior Repairs Noted Throughout

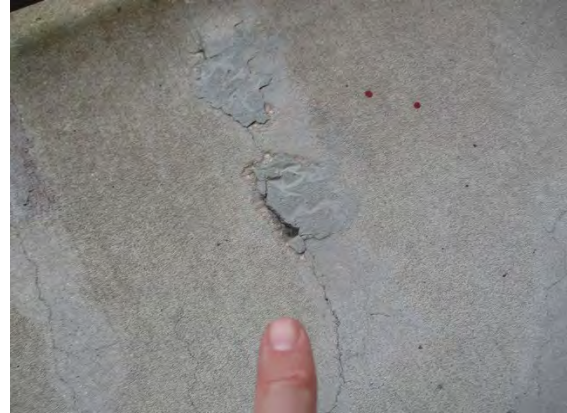
19 2nd Floor Walkway Concrete Spalling with Exposed Rebar (Corroded) Multiple Areas

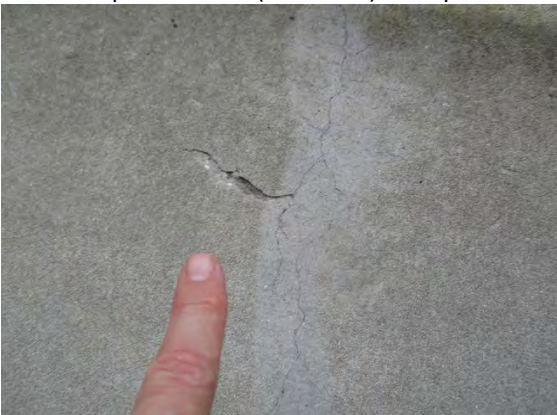
20 2nd Floor Walkway Concrete Spalling Multiple Areas

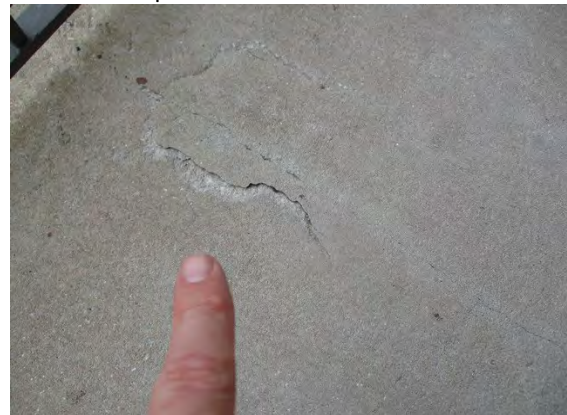
21 2nd Floor Walkway Concrete Spalling Multiple Areas

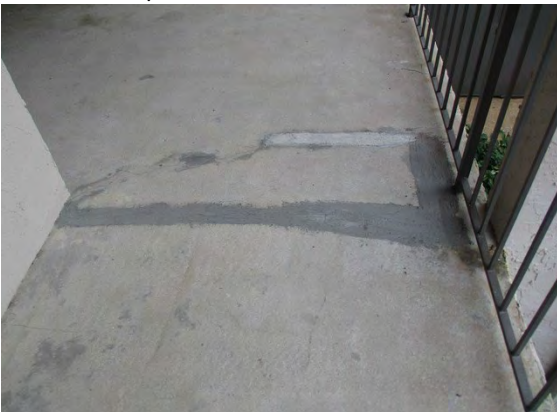
22 2nd Floor Walkway Concrete Spalling Multiple Areas

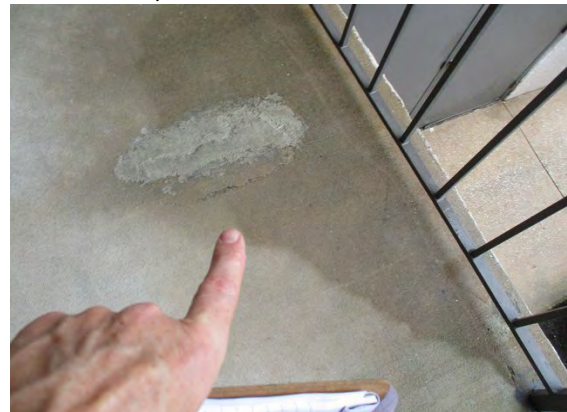
23 2nd Floor Walkway Prior Repairs Noted Throughout

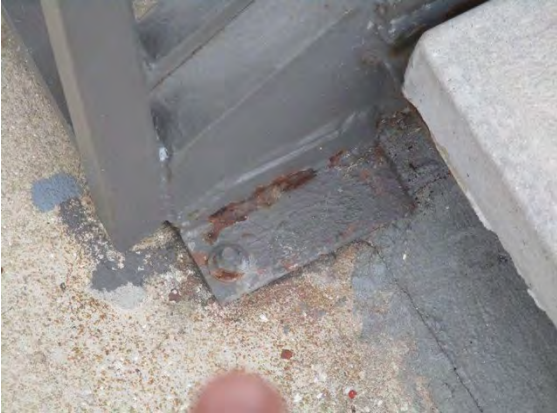
26 Right & Left Stairwells Corroded At Connection Points

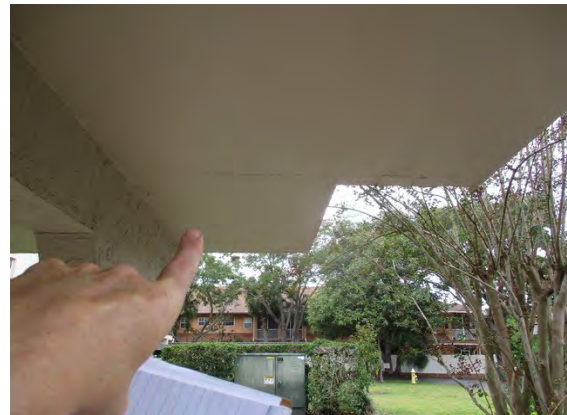
29 1st Floor Walkway Ceiling Prior Repair With Displacement Left Side of Building

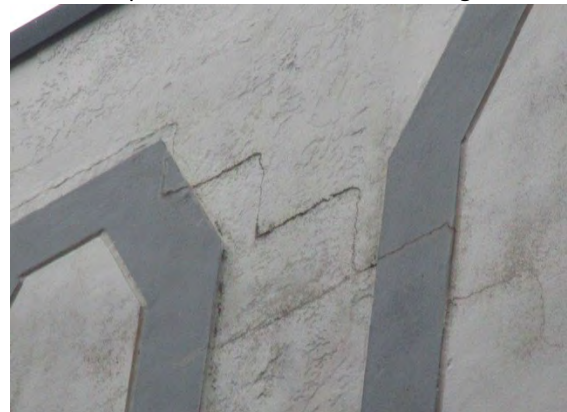
31 Moderate Step Crack With Displacement Rear of Building

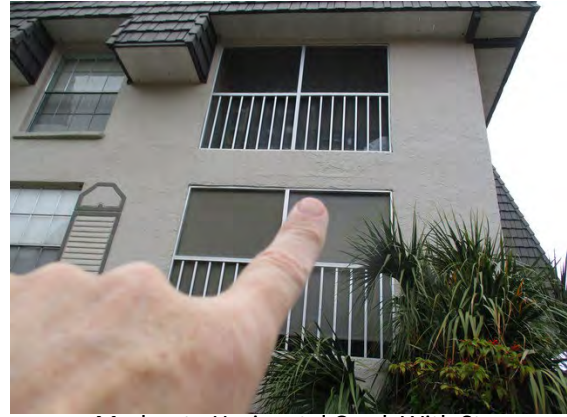
33 Moderate Step Crack With Displacement
Rear of Building
