Reserve Study

Cordova Greens V COA

This Report contains Structural Reserve Study for the Property
with Address of:

November 15, 2023

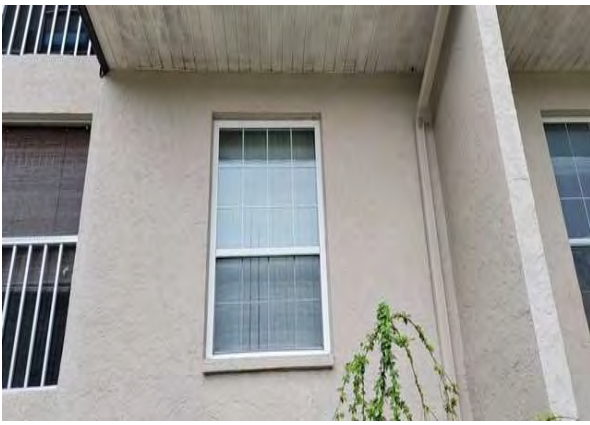
33 Unit 204 Cracked Sill

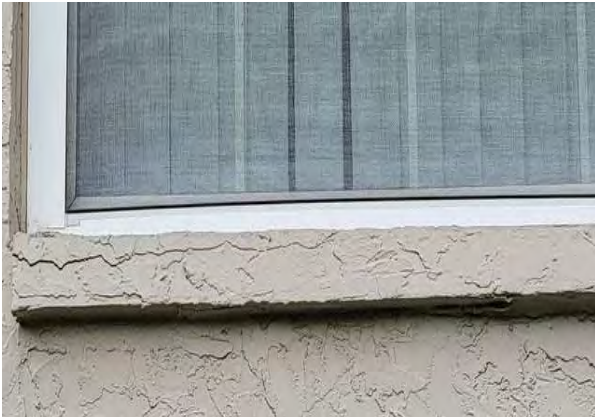
34 Unit 204 Cracked Sill

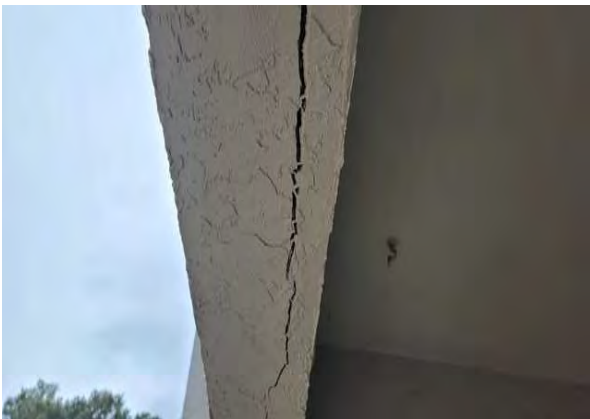
36 Unit 103 Cracked Support

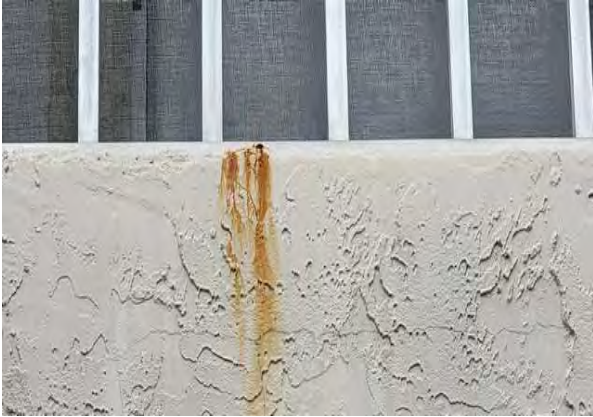
42 Unit 202 Rust at Balcony

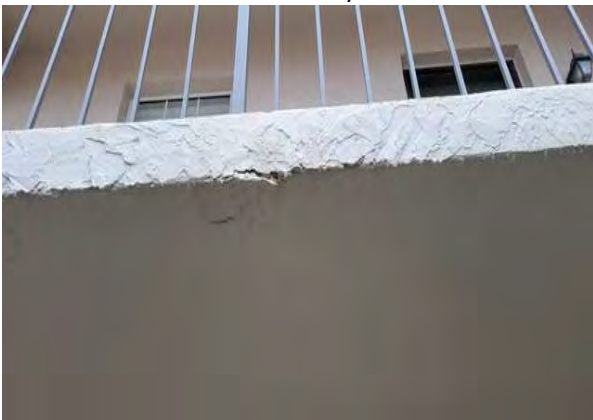
44 Cracked Walk Above Unit 102

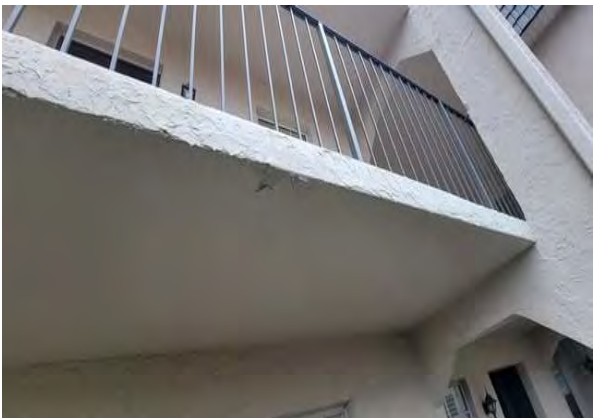
46 Cracked Walk Above Unit 102

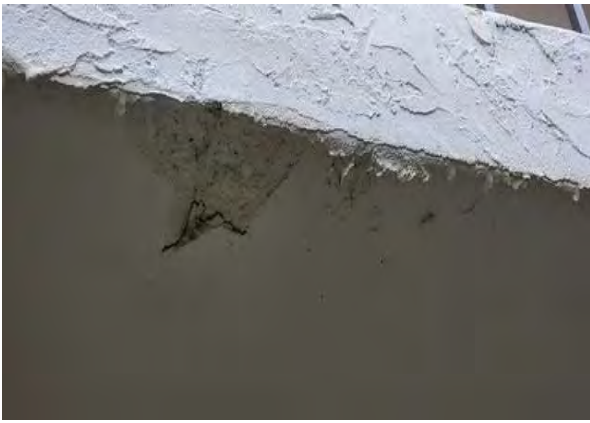
48 Cracked Walk Above Unit 102

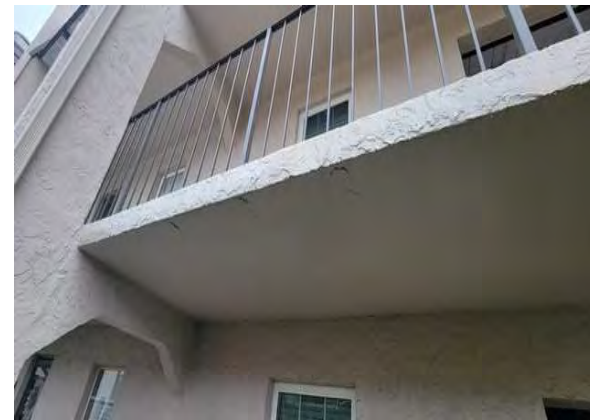
52 Crack in Wall Near Unit 103

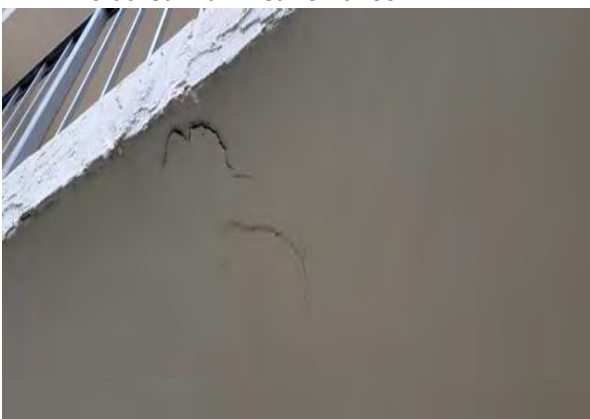
54 Cracked Walk Near Unit 106

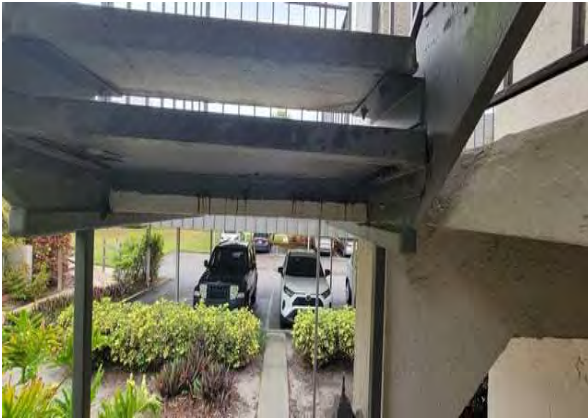
58 Rusted Stringer Right Staircase 1st Floor

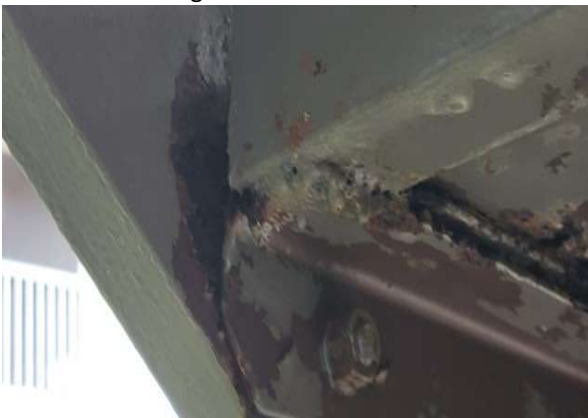
62 Rusted Right Staircase 1st Floor

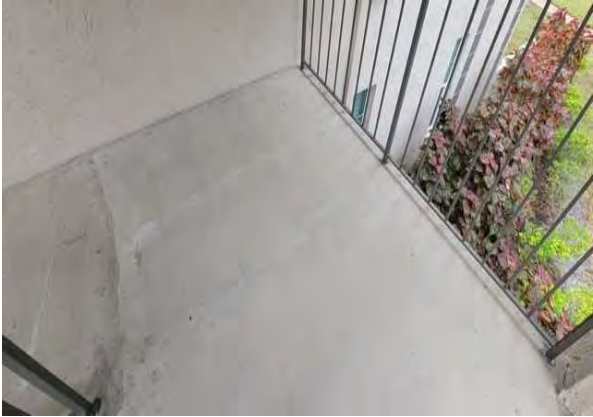
66 2nd Floor Right Staircase Spalled Concrete

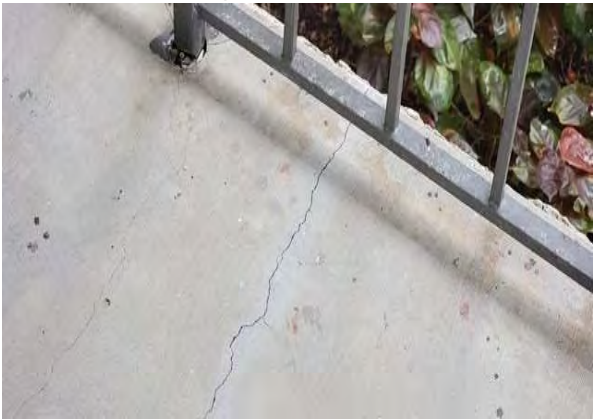
68 2nd Floor Right Staircase Cracked Walk

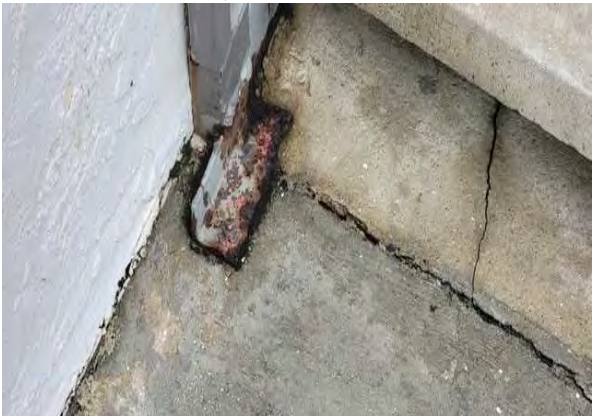
70 2nd Floor Right Staircase Rusted Bracket

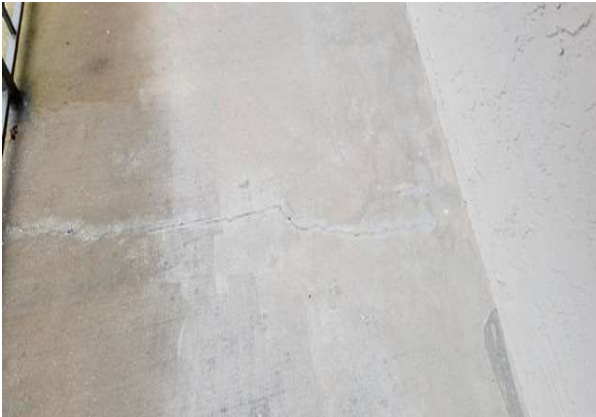
74 Cracked Walk Multiple Areas 2nd Floor

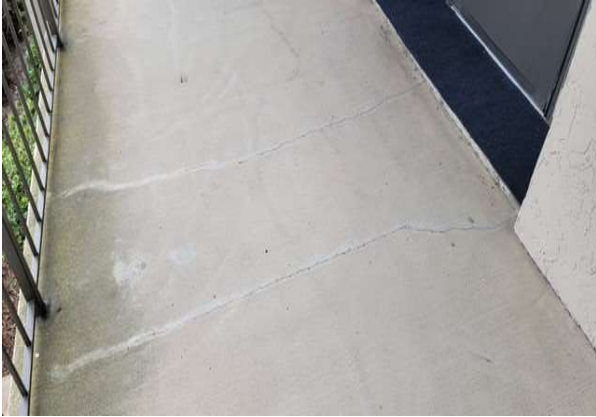
82 Cracked Walk Near 2nd Floor Elevator Door

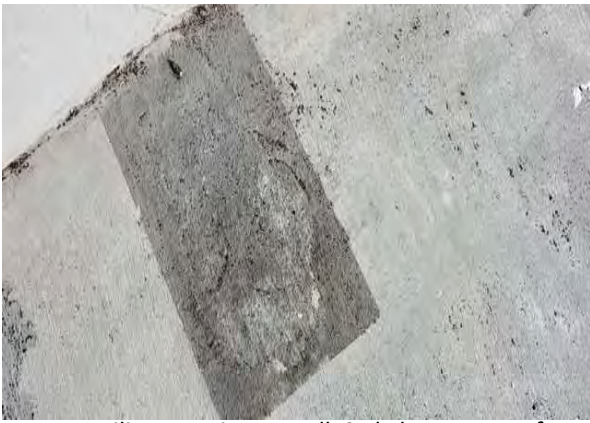
88 Failing Repairs to Walk 3rd Floor Near Left Stairs

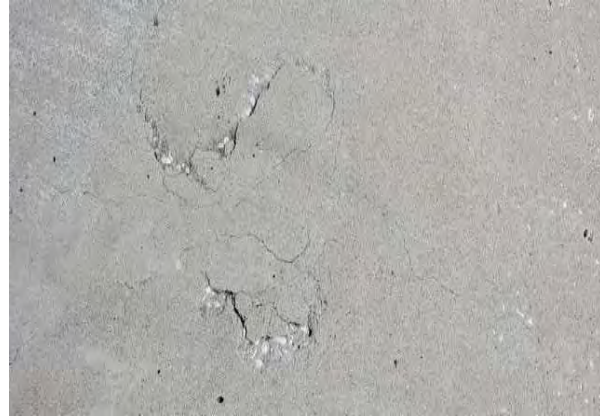
91 Spalled Concrete Near Unit 301

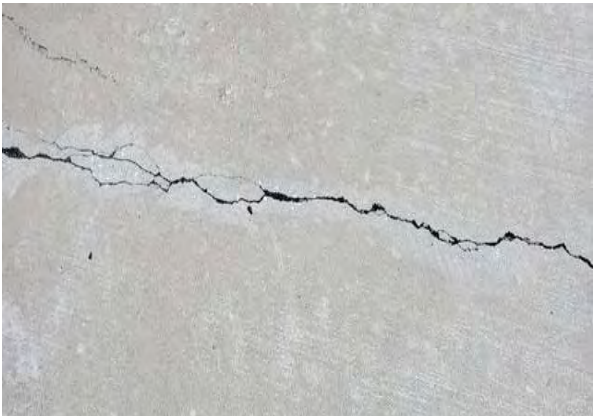
102 Cracked Walk Near Unit 305

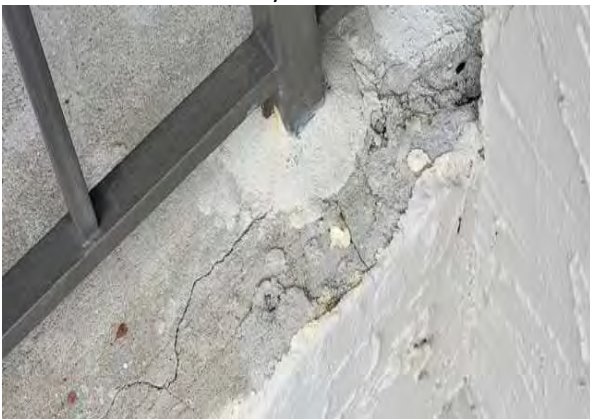
35 Cracked Walkway Near 303 Exposed Rebar

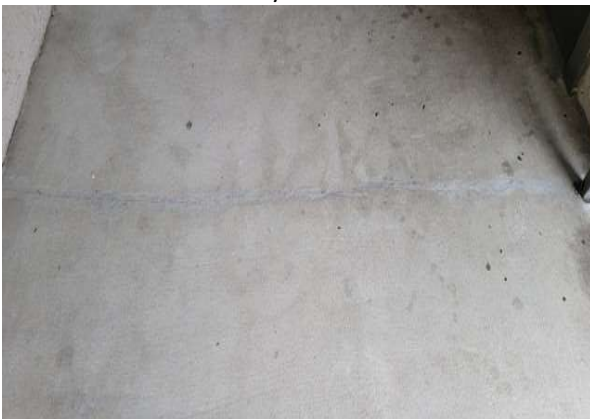
37 Cracked Walkway 3rd Floor Elevator Lobby

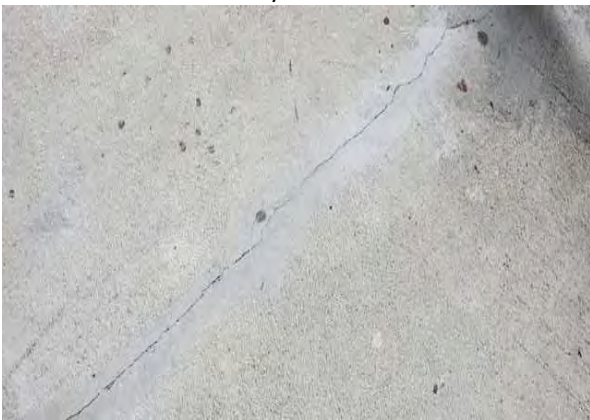
43 Crack in Walkway Near Unit 304

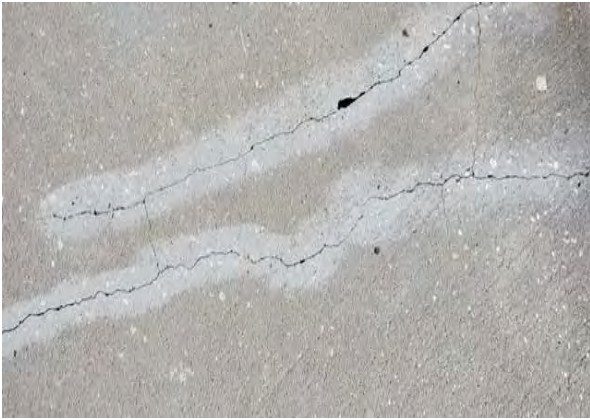
49 Crack in Walkway Near Unit 306

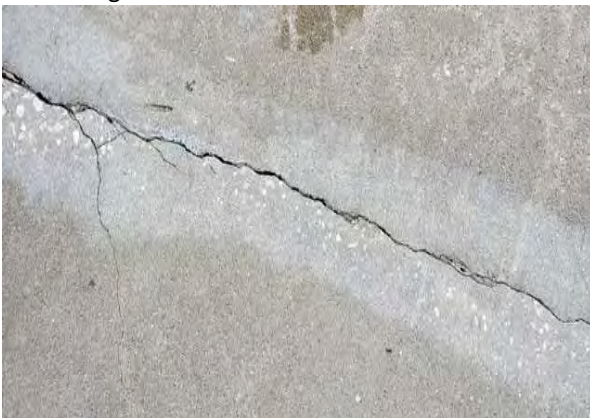
53 Crack in Walkway Base of Stairs 2nd Floor
Right Side

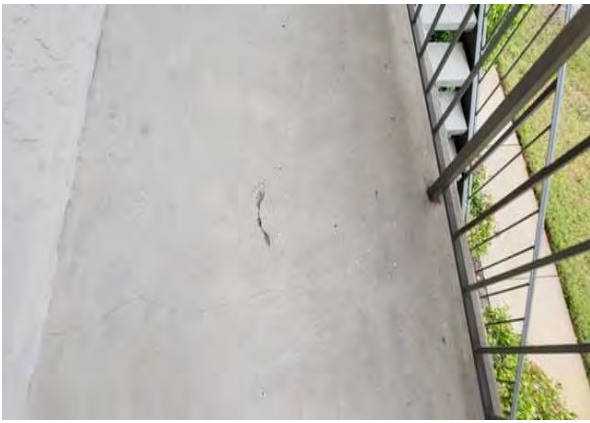
55 Spalled Concrete 2nd Floor Near Right Stairs

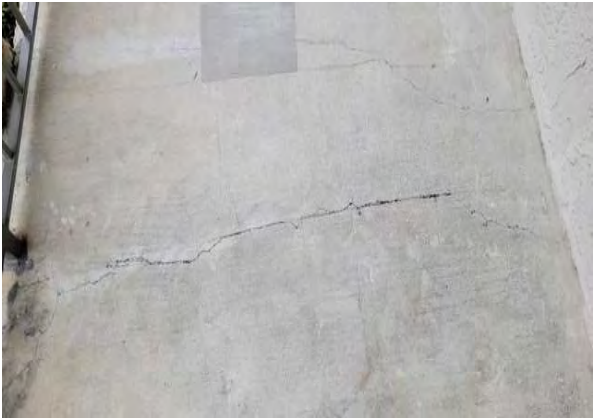
65 Crack in Walkway Near Unit 205

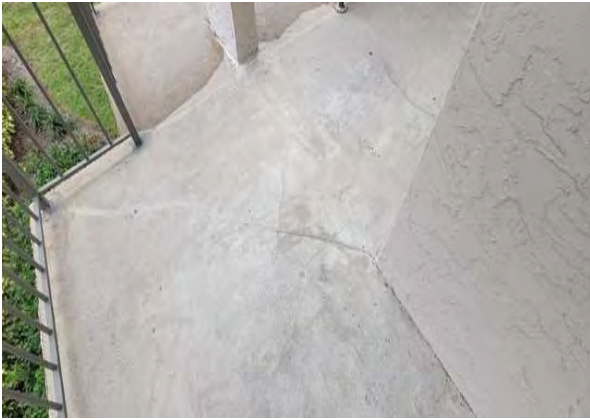
73 Crack in Walkway Near Unit 204

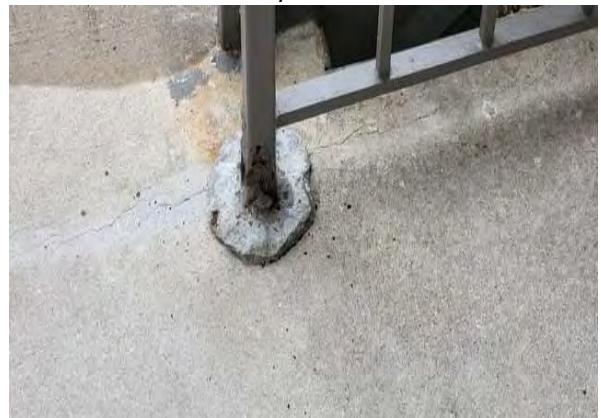
78 2nd Floor Rusted Handrail Left Stairs

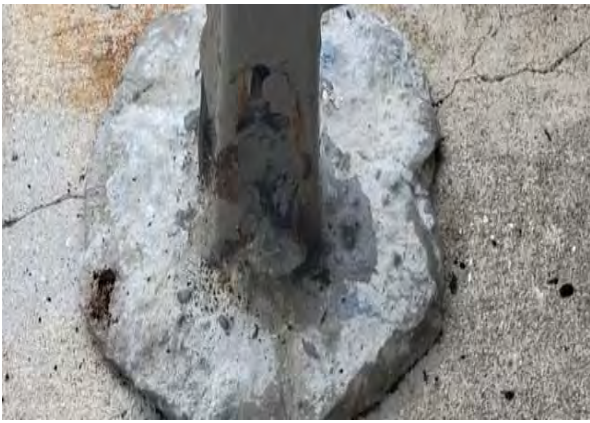
79 2nd Floor Rusted Handrail Left Stairs

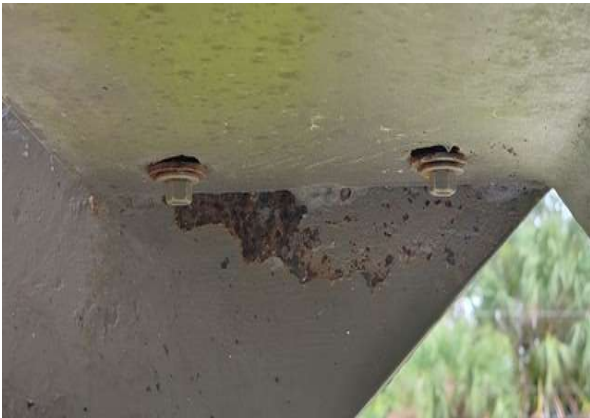
83 Rusted Stringer 2nd Floor to 3rd Floor at Left Stairs

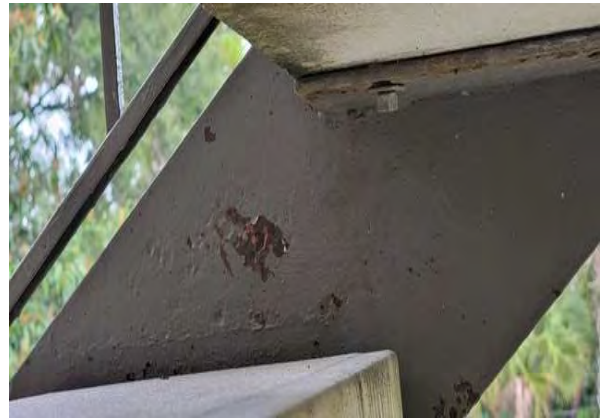
84 Rusted Stringer 2nd Floor to 3rd Floor at Left Stairs

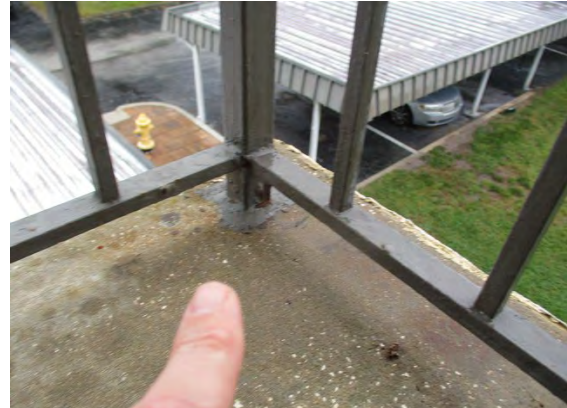
6 3rd Floor Railing Corroded In Multiple Areas

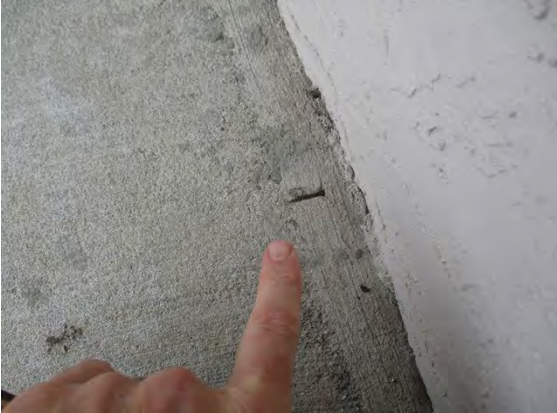
11 3rd Floor Walkway Concrete Spalling With Rebar Exposed & Corroded Multiple Areas

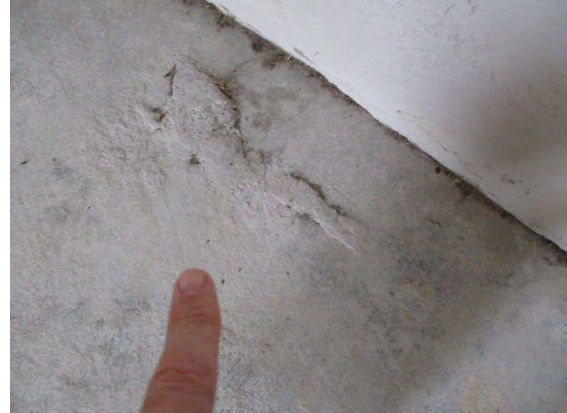
12 3rd Floor Walkway Concrete Spalling Multiple Areas

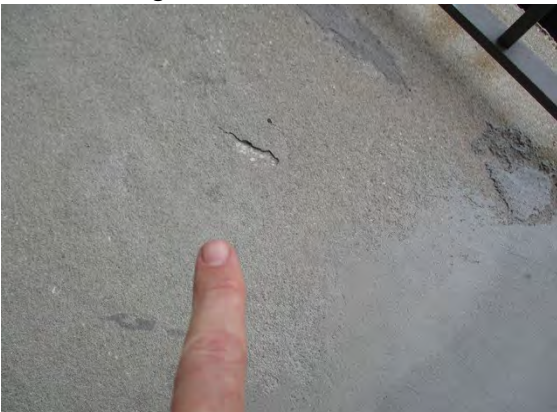
15 3rd Floor Walkway Concrete Spalling Multiple Areas

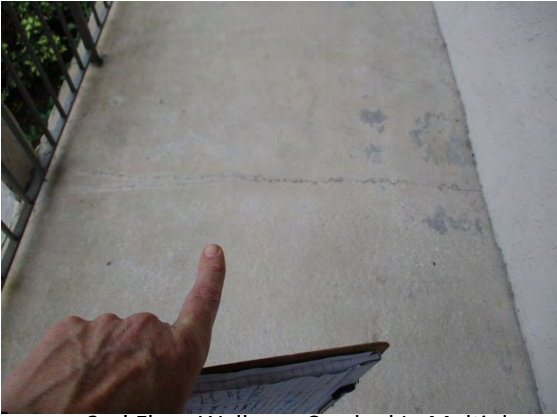
17 2nd Floor Walkway Cracked In Multiple Areas

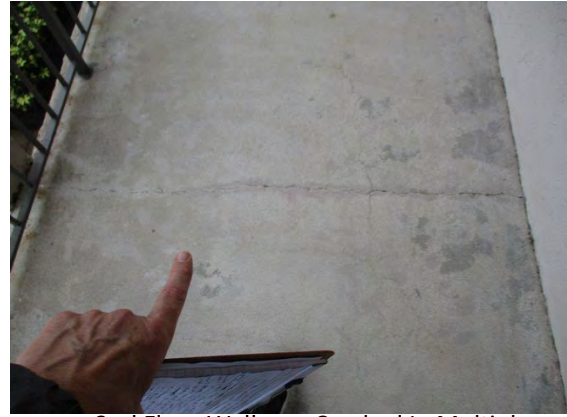
18 2nd Floor Walkway Cracked In Multiple Areas

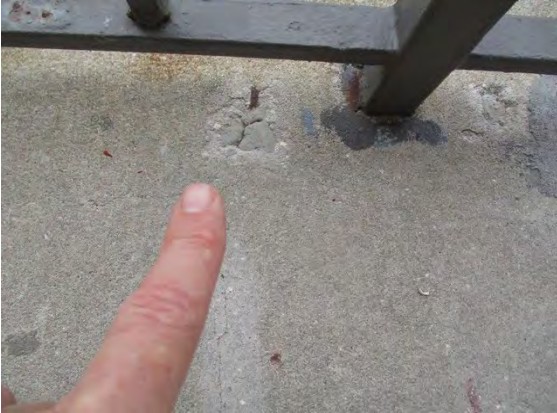
19 2nd Floor Walkway Concrete Spalling with Exposed Rebar (Corroded) Multiple Areas

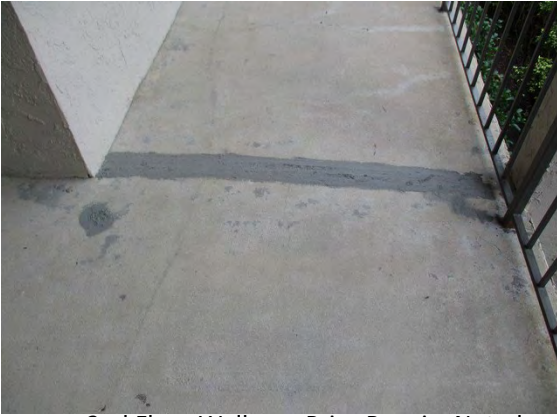
25 2nd Floor Walkway Prior Repairs Noted Throughout

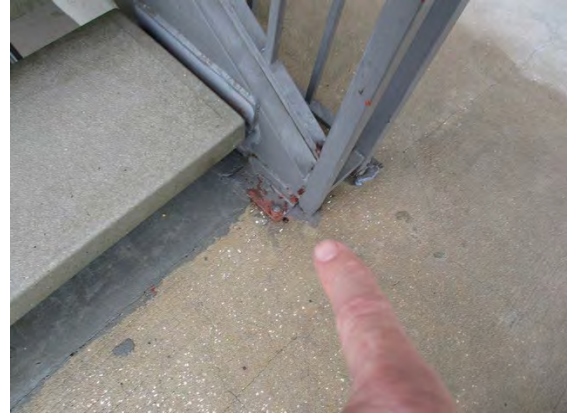
28 Right & Left Stairwells Corroded At Connection Points

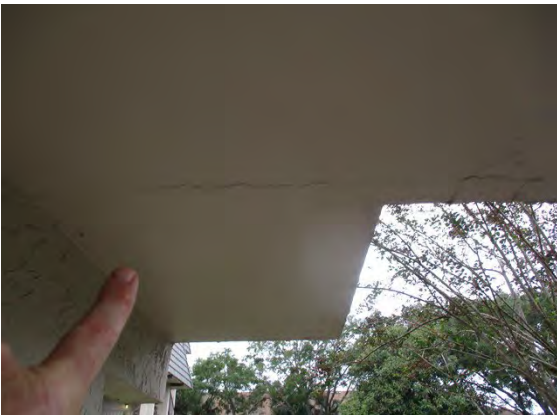
29 1st Floor Walkway Ceiling Prior Repair With Displacement Left Side of Building

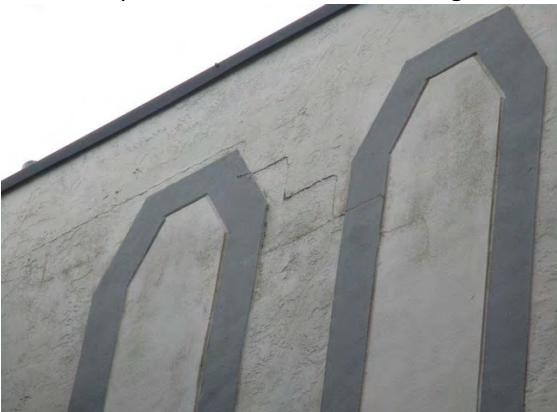
31 Moderate Step Crack With Displacement Rear of Building

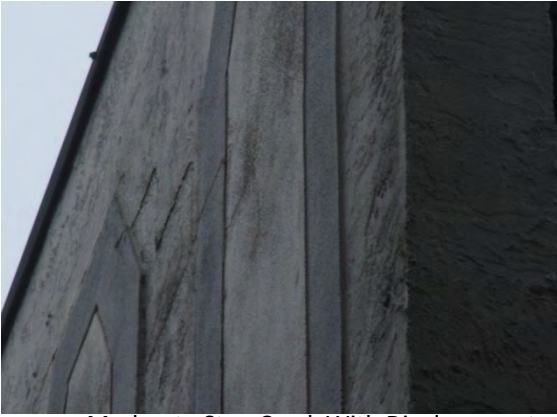
33 Moderate Step Crack With Displacement
Rear of Building

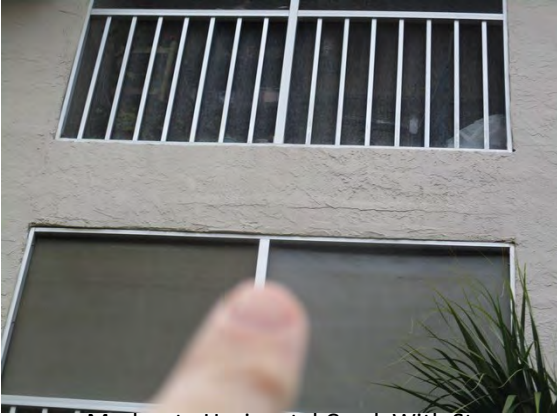
35 Moderate Horizontal Crack With Stucco
Bulging Rear Left Side of Building
