Milestone Inspection – Phase 1

Cordova Greens V COA

8799 Bardmoor Blvd. Largo, FL 33777

November 15, 2023

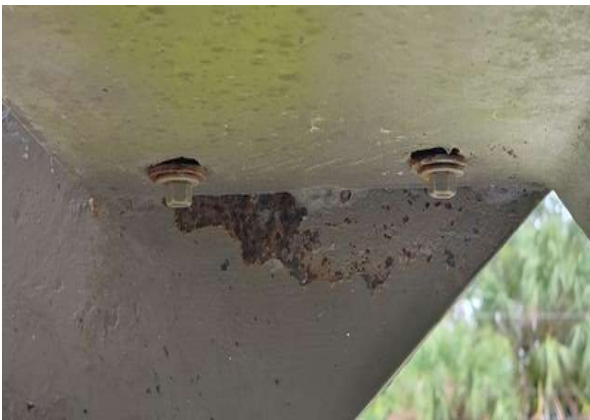
84 Rusted Stringer 2nd Floor to 3rd Floor at Left Stairs
