Reserve Study

Cordova Greens V COA

This Report contains Structural Reserve Study for the Property
with Address of:

November 15, 2023

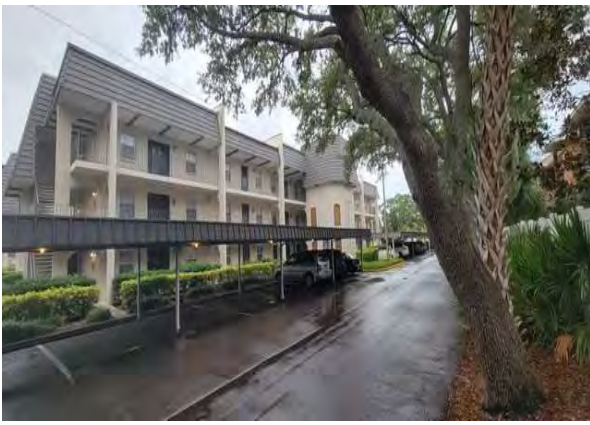
105 Spalled Concrete Near Unit 305

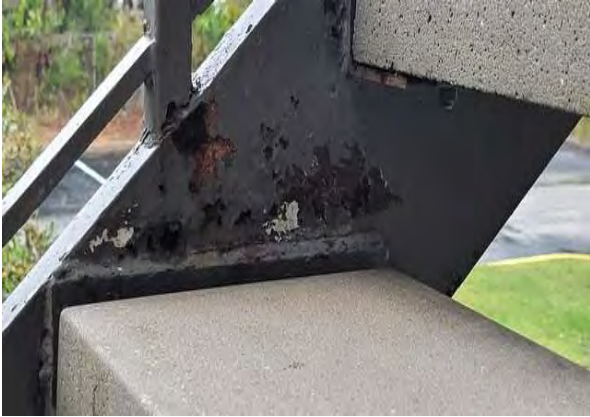
81 Rusted Stringer 2nd Floor to 3rd Floor at Left Stairs

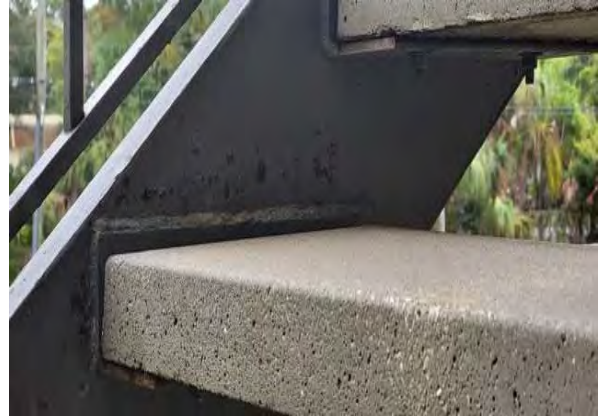
82 Rusted Stringer 2nd Floor to 3rd Floor at Left Stairs

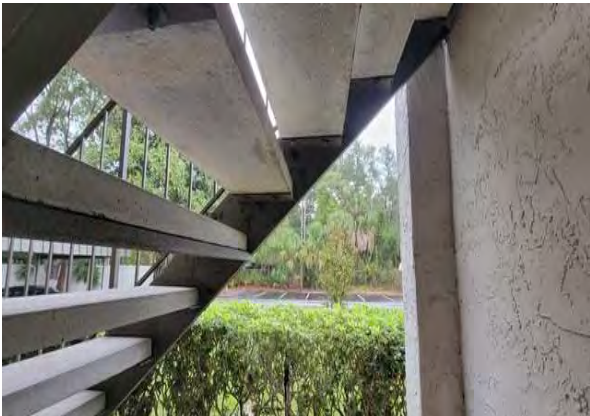
85 Rusted Stringer 2nd Floor to 3rd Floor at Left Stairs

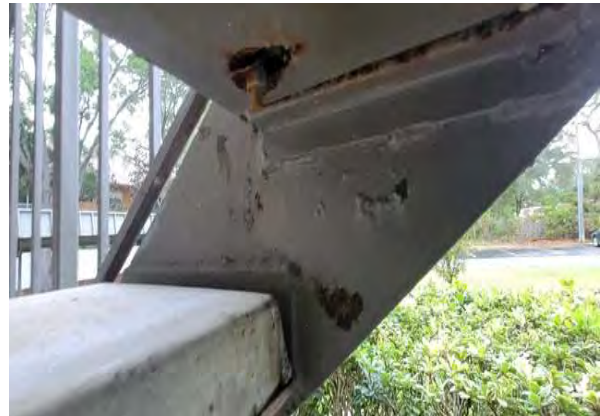
86 Rusted Stringer 2nd Floor to 1st Floor at Left Stairs

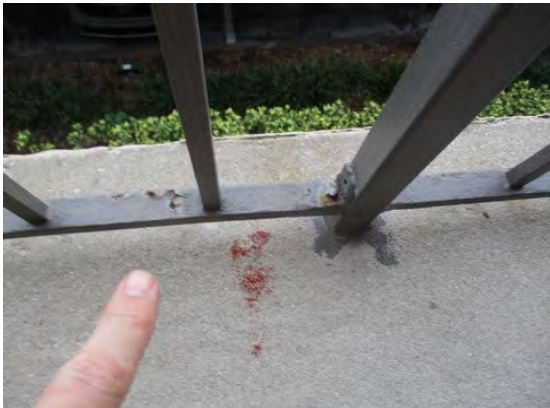
5 3rd Floor Railing Corroded In Multiple Areas
